FRACTOGRAPHY REPORT

GENERAL ANALYSIS OF SUPPLIED MATERIAL

PROJECT NO.: 6032-106551-2
REVISION NO.: 0
DATE: June 11, 2021
AUTHORIZATION: P1073-SBIR2

Material: AL7075-T651
Sample No.: NB 9 and ECNR 8
Specimen Size: 106551-1 Rev. 2
Number of samples: 2

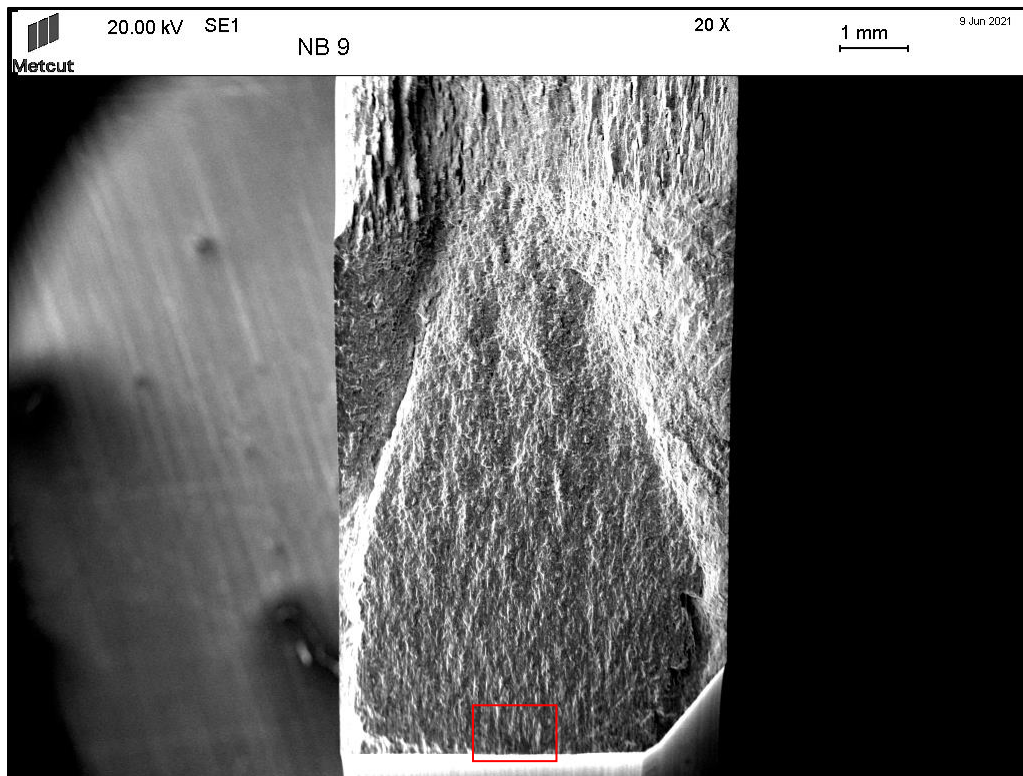
Figure 1. Fracture face of sample NB 9, Site 1 is shown at low magnification, (SEI mode, 0° tilt). The red box identifies the initiation site.

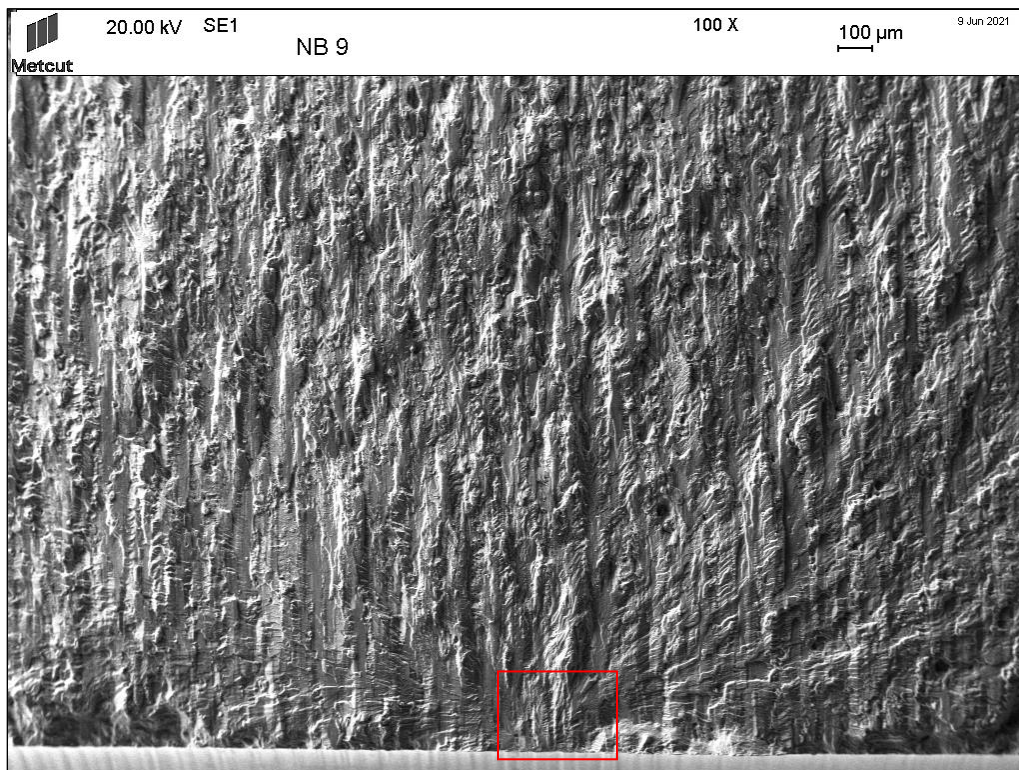
Figure 2. Fracture face of sample NB 9, Site 1 is viewed at intermediate magnification, (SEI mode, 0° tilt). A red box identifies the initiation site.

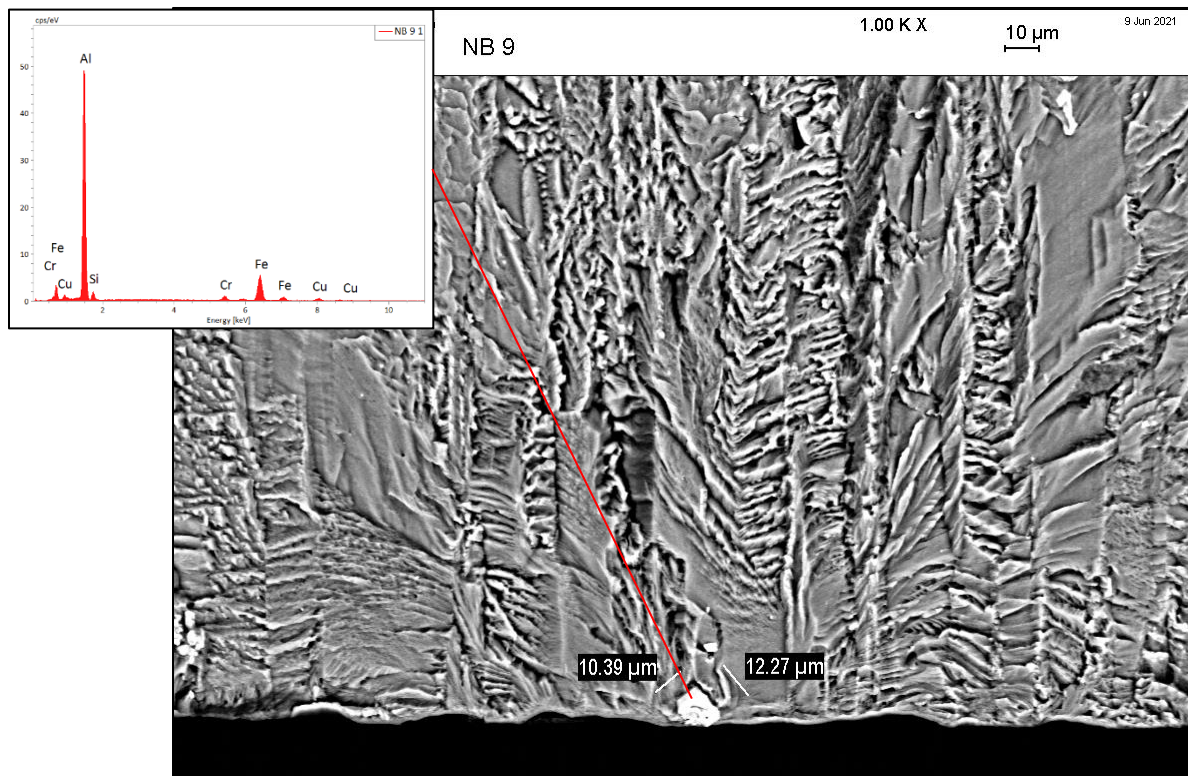
Figure 3. Initiation site for specimen NB 9, Site 1 is seen at higher magnification, (BEI mode, 0° tilt). Inclusion at the surface measuring 10.4 μm x 12.3 μm was observed at the initiation site. Inclusion contains mostly Aluminum with concentrations of Iron, Copper, Silicon and Chromium.

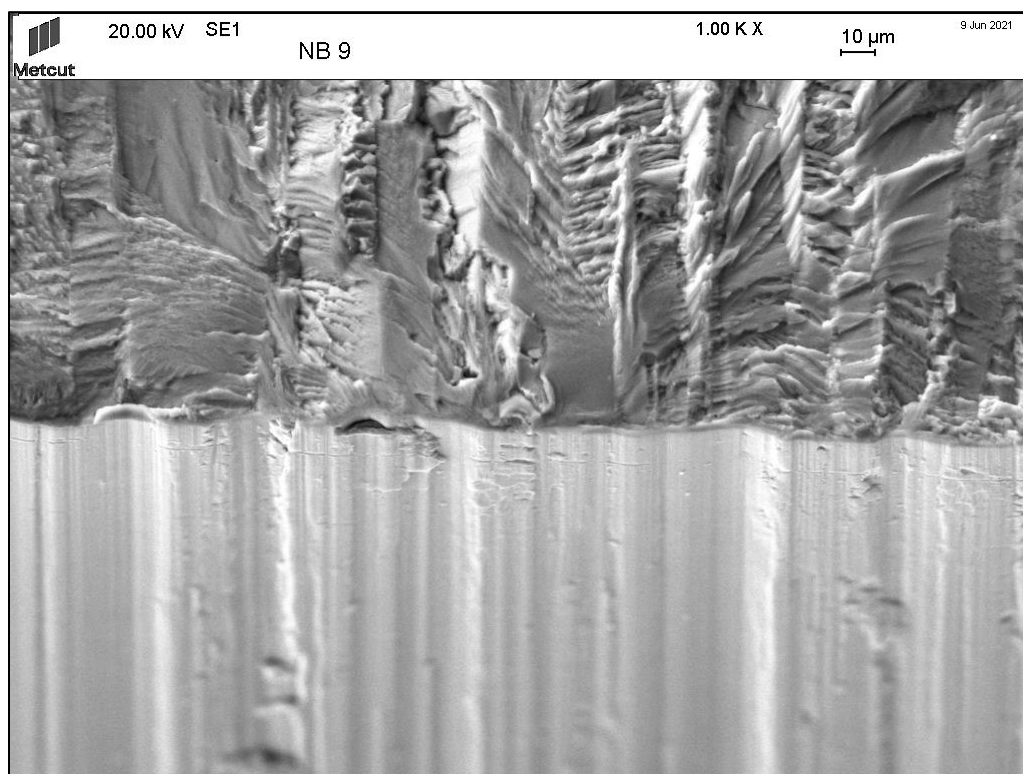
Figure 4. Initiation site for specimen NB 9, Site 1 is seen at higher magnification, (SEI mode, 15° tilt).

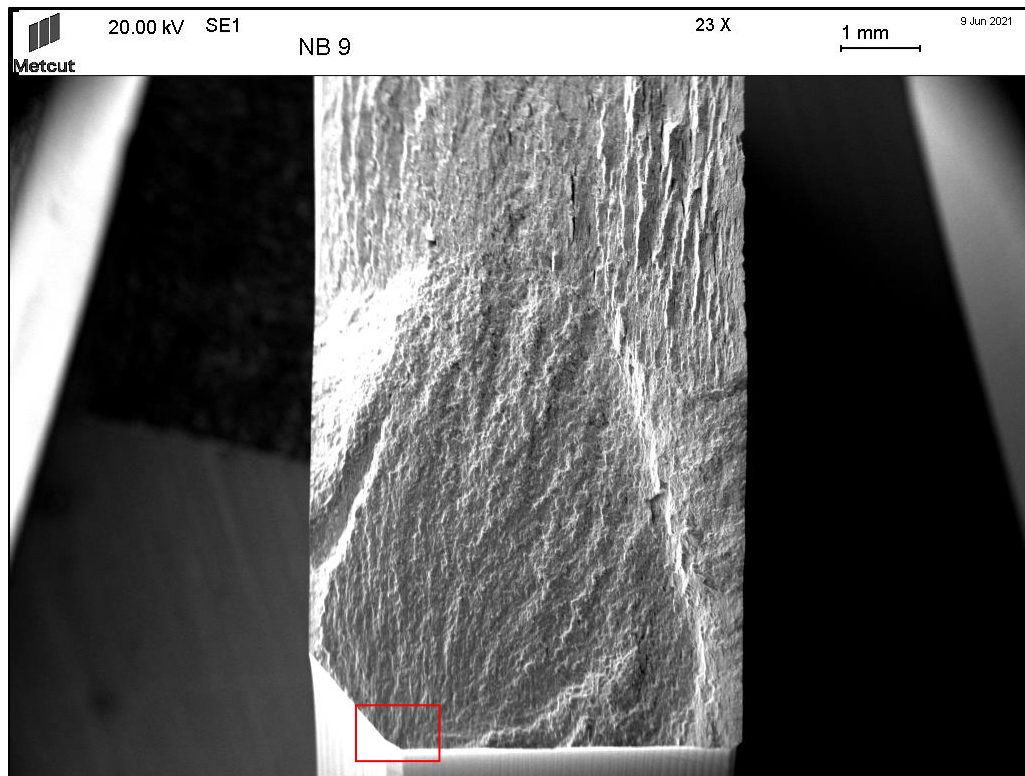
Figure 5. Fracture face of sample NB 9, Site 2 is shown at low magnification, (SEI mode, 0° tilt). The red box identifies the initiation site.

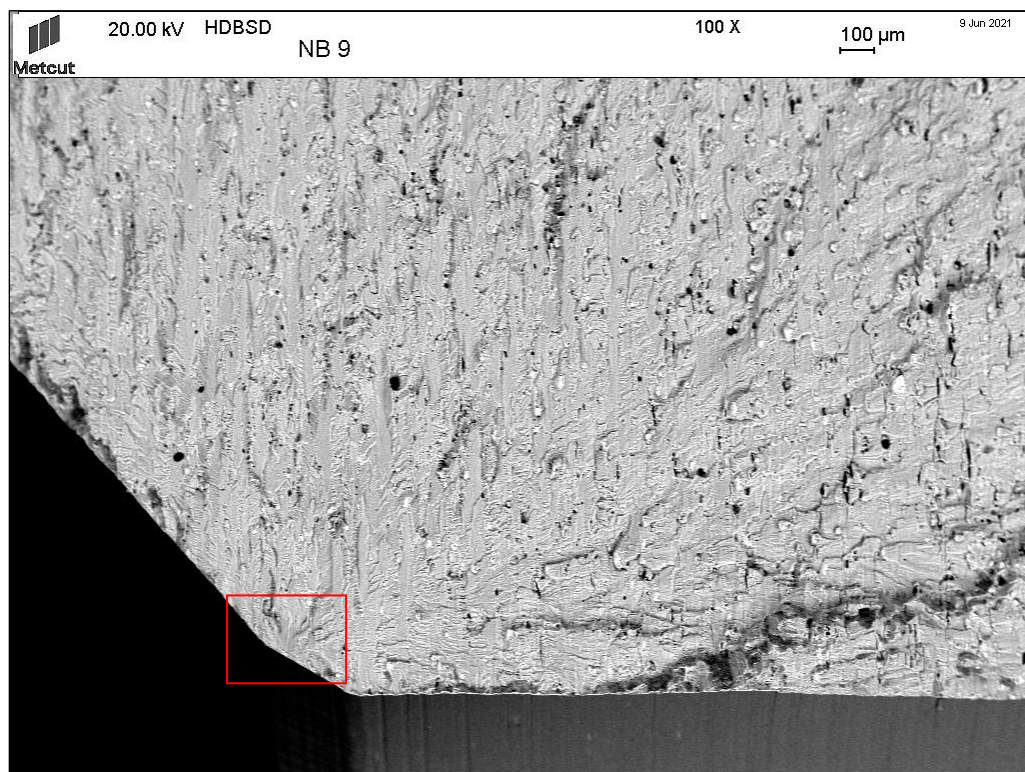
Figure 6. Fracture face of sample NB 9, Site 2 is viewed at intermediate magnification, (SEI mode, 0° tilt). A red box identifies the initiation site.

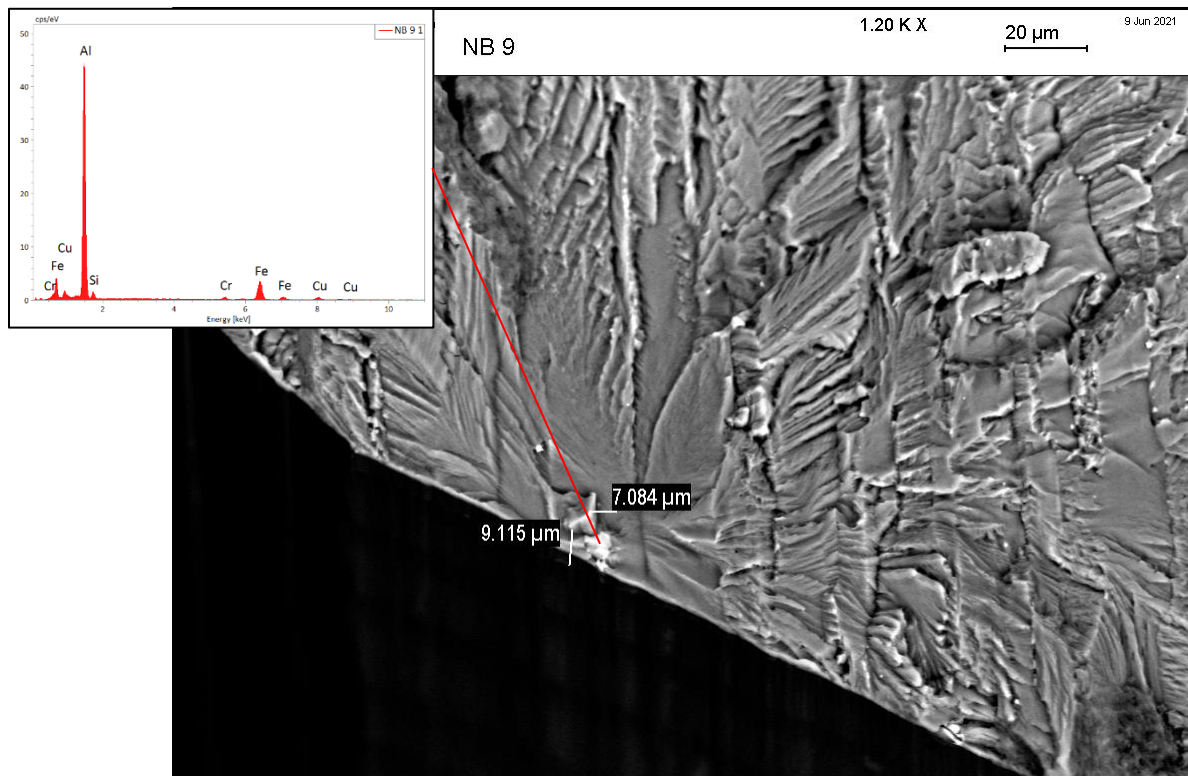
Figure 7. Initiation site for specimen NB 9, Site 2 is seen at higher magnification, (BEI mode, 0° tilt). Inclusion at the surface measuring 7.1 µm x 9.1 µm was observed at the initiation site. Inclusion contains mostly Aluminum with concentrations of Iron, Copper, Silicon and Chromium.

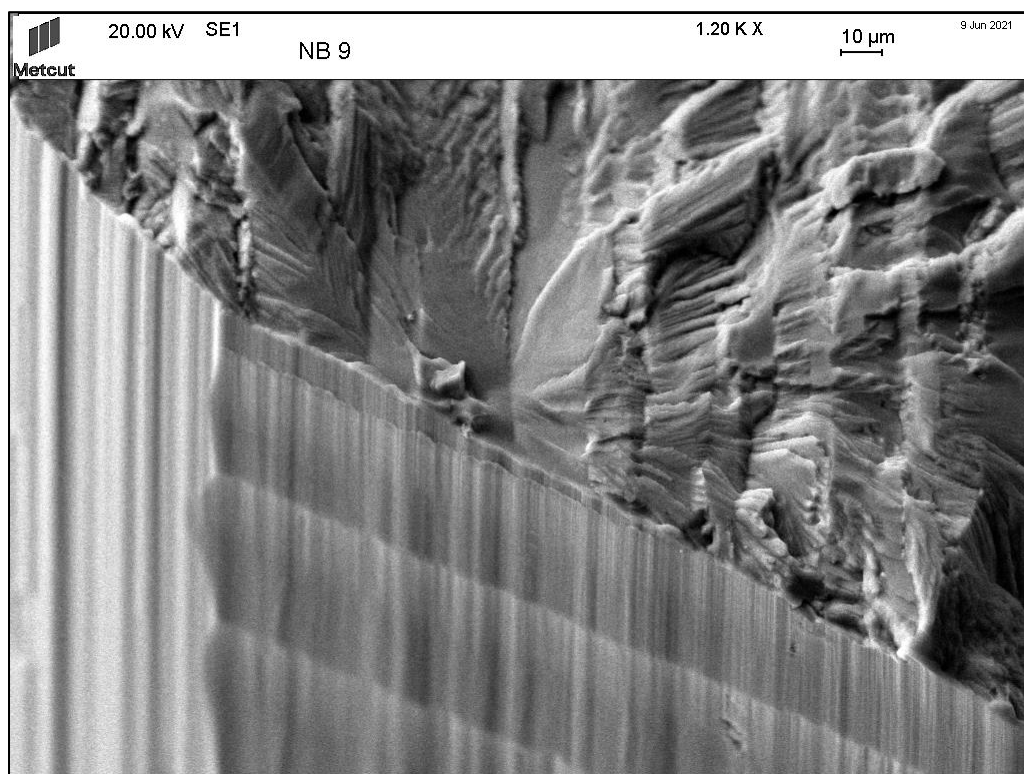
Figure 8. Initiation site for specimen NB 9, Site 2 is seen at higher magnification, (SEI mode, 15° tilt).

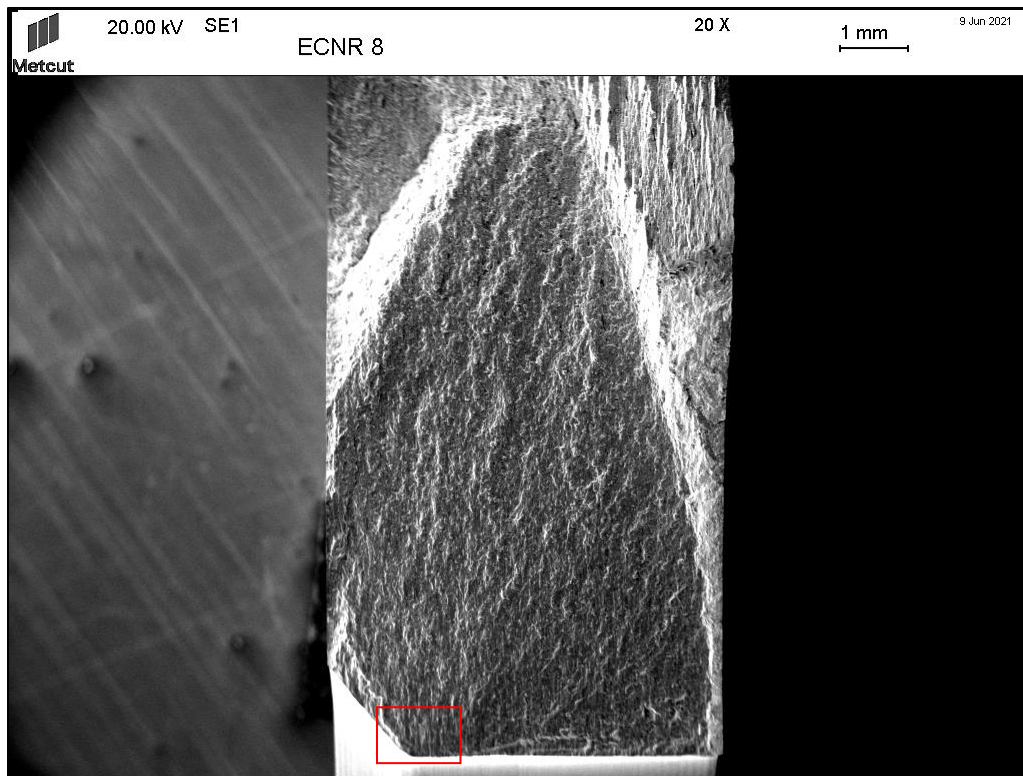
Figure 9. Fracture face of sample ECNR 8, Site 1 is shown at low magnification, (SEI mode, 0° tilt). The red box identifies the initiation site.

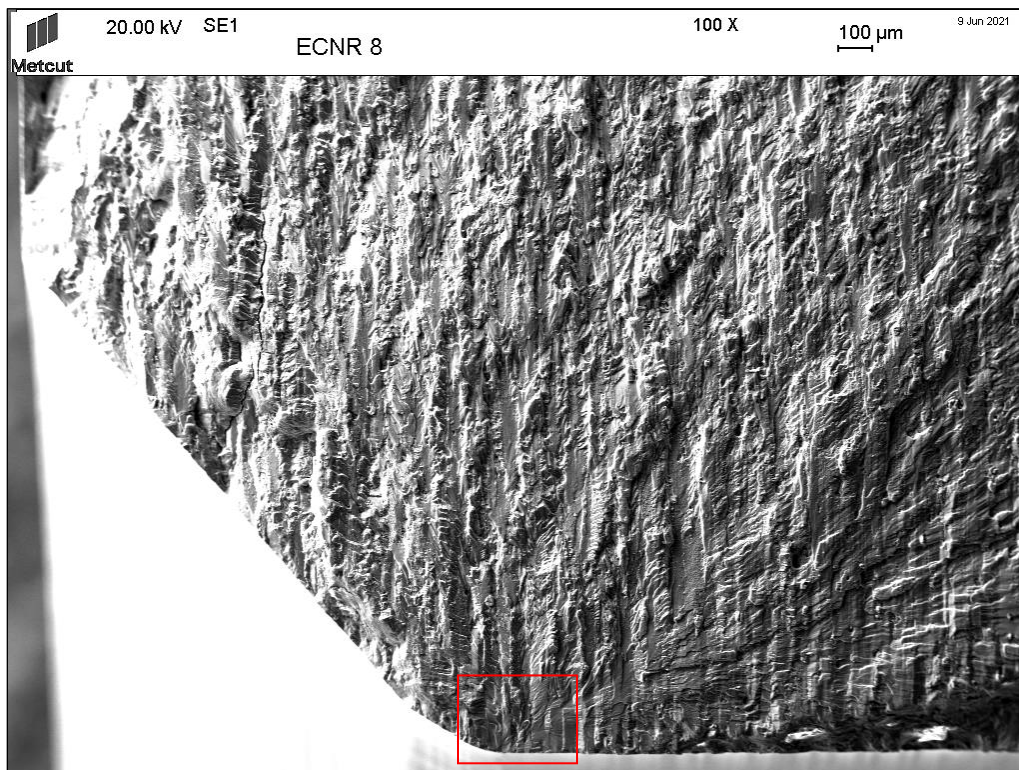
Figure 10. Fracture face of sample ECNR 8, Site 1 is viewed at intermediate magnification, (SEI mode, 0° tilt). A red box identifies the initiation site.

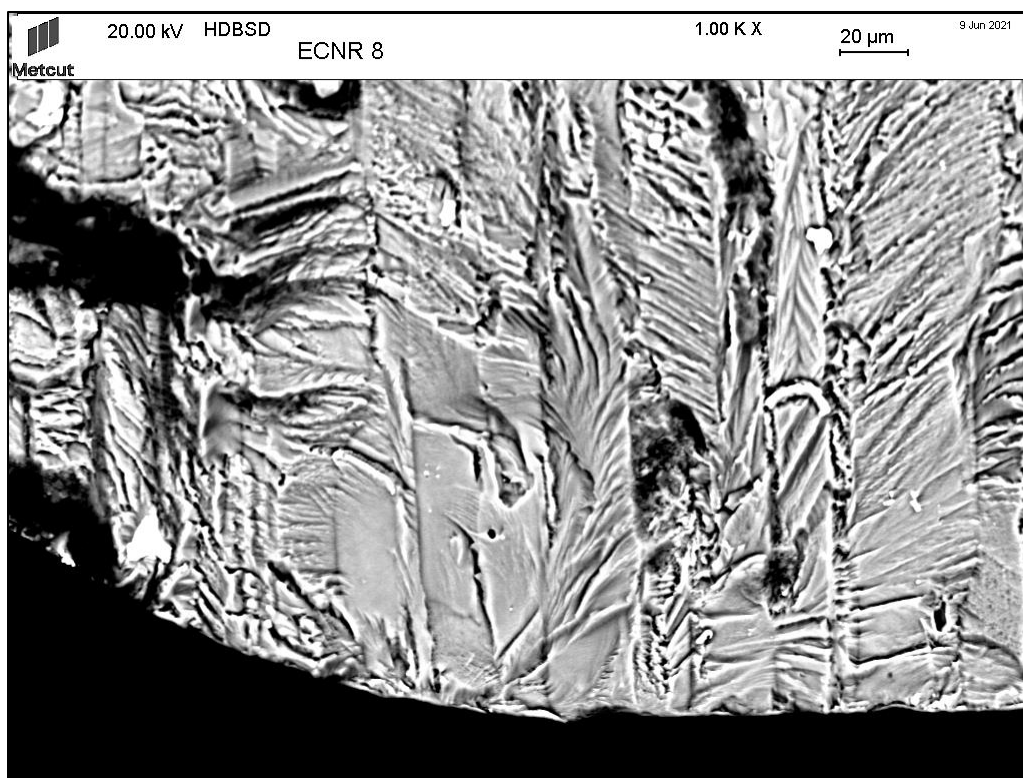
Figure 11. Initiation site for specimen ECNR 8, Site 1 is seen at higher magnification, (BEI mode, 0° tilt). Grain failure at the surface was observed at the initiation site.

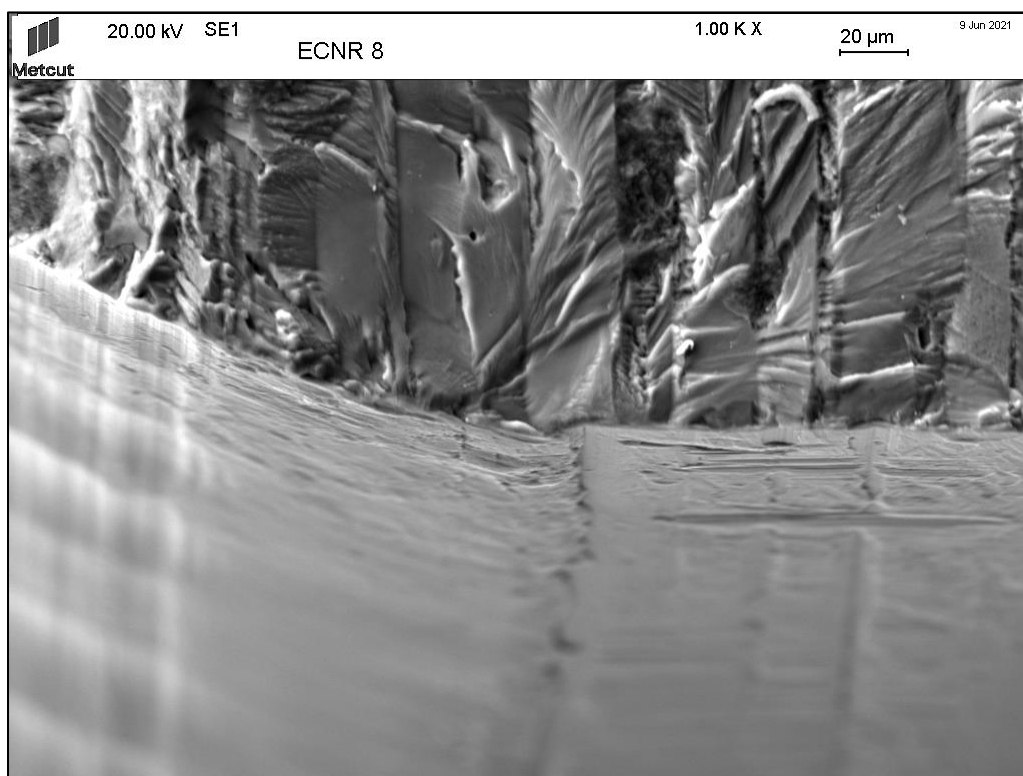
Figure 12. Initiation site for specimen ECNR 8, Site 1 is seen at higher magnification, (SEI mode, 15° tilt).

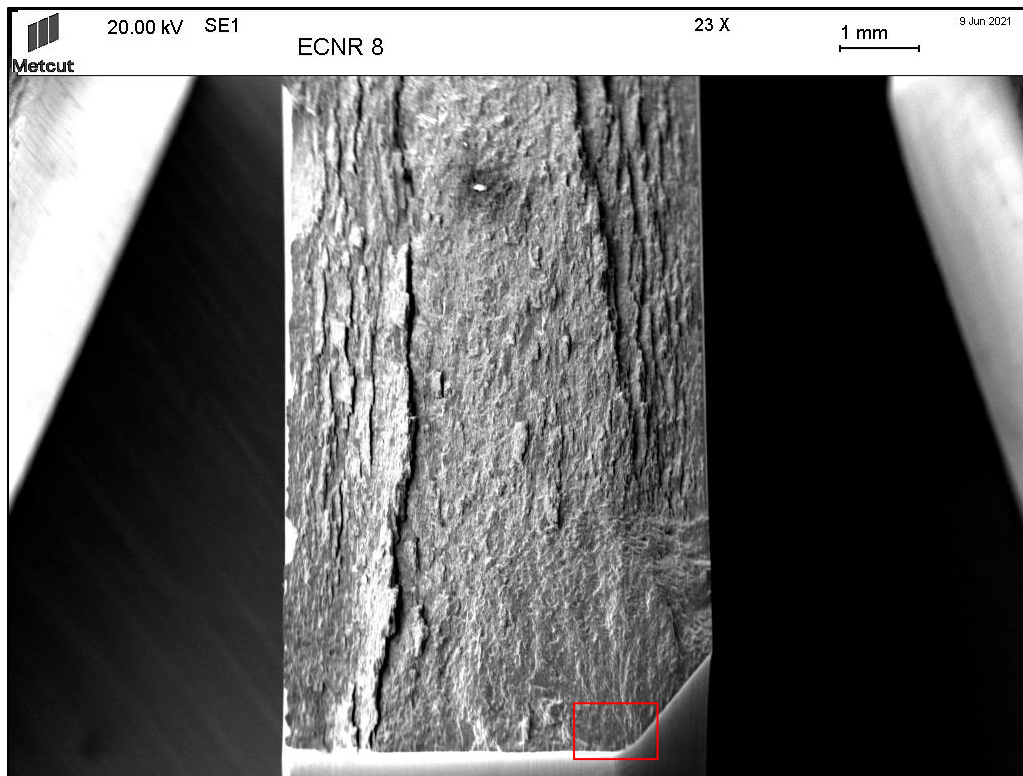
Figure 13. Fracture face of sample ECNR 8, Site 2 is shown at low magnification, (SEI mode, 0° tilt). The red box identifies the initiation site.

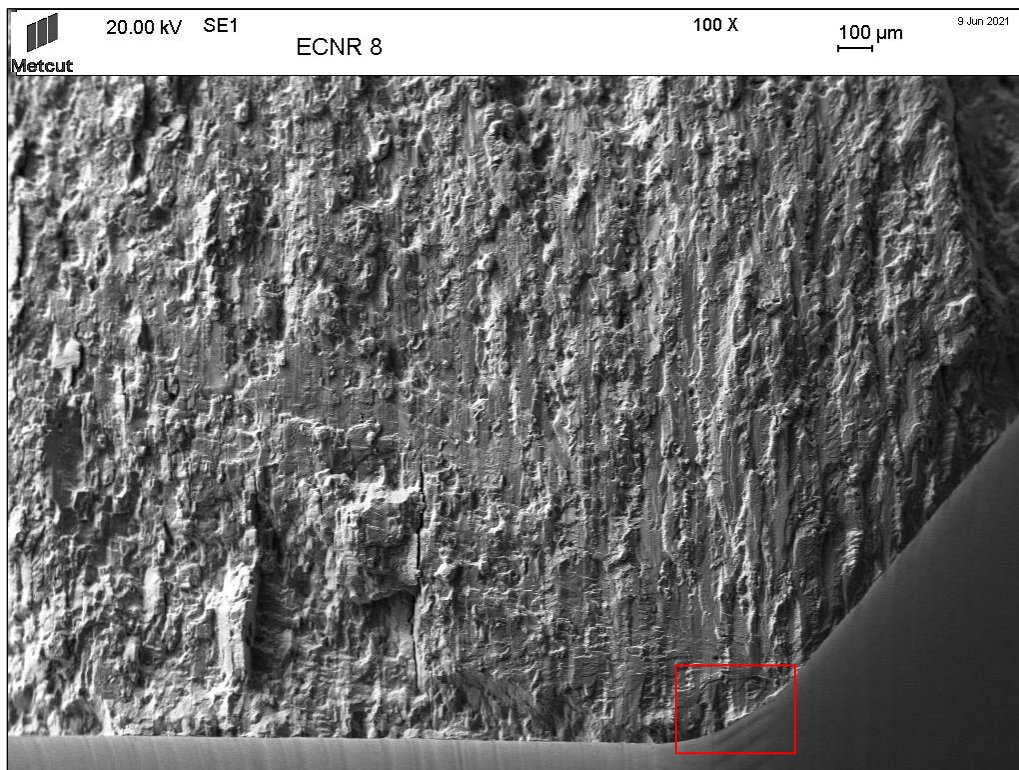
Figure 14. Fracture face of sample ECNR 8, Site 2 is viewed at intermediate magnification, (SEI mode, 0° tilt). A red box identifies the initiation site.

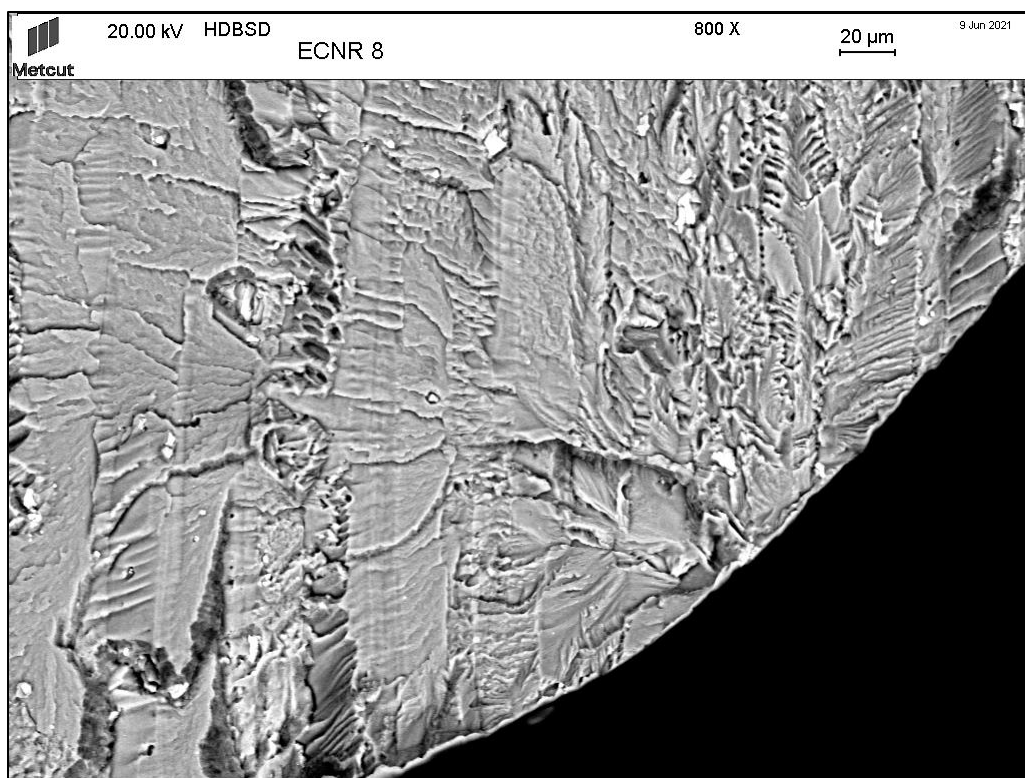
Figure 15. Initiation site for specimen ECNR 8, Site 2 is seen at higher magnification, (BEI mode, 0° tilt). Grain failure at the surface was observed at the initiation site.

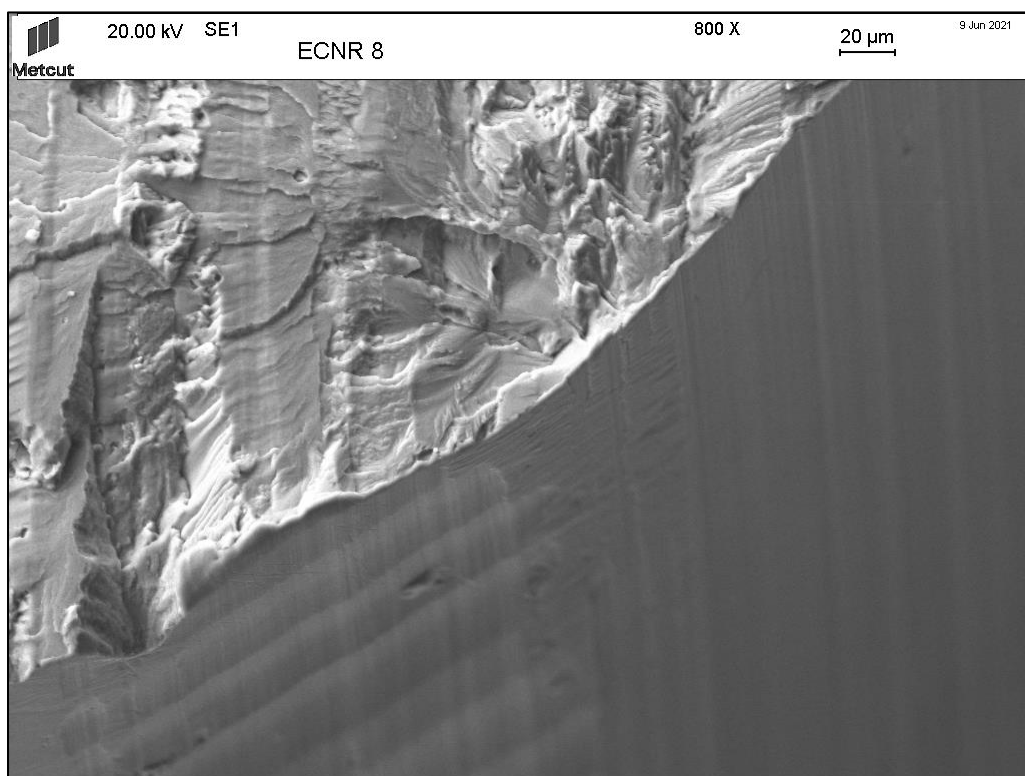
Figure 16. Initiation site for specimen ECNR 8, Site 2 is seen at higher magnification, (SEI mode, 15° tilt).
