FRACTOGRAPHY REPORT GENERAL ANALYSIS OF SUPPLIED MATERIAL

PROJECT NO.: 6032-106551-3
REVISION NO.: 0
DATE: June 16, 2021
AUTHORIZATION: P1073-SBIR2

Material: AL7075-T651
Sample No.: BX 7 and XREC 7
Specimen Size: 106551-1 Rev. 2
Number of samples: 2

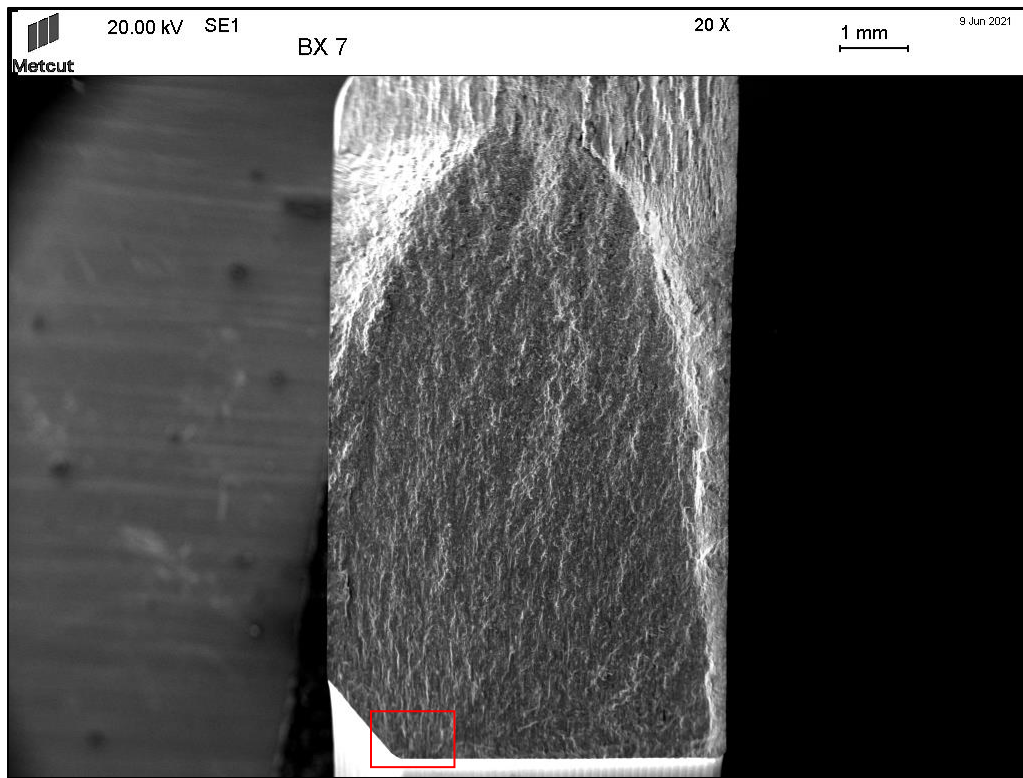
Figure 1. Fracture face of sample BX 7, Site 1 is shown at low magnification, (SEI mode, 0° tilt). The red box identifies the initiation site.

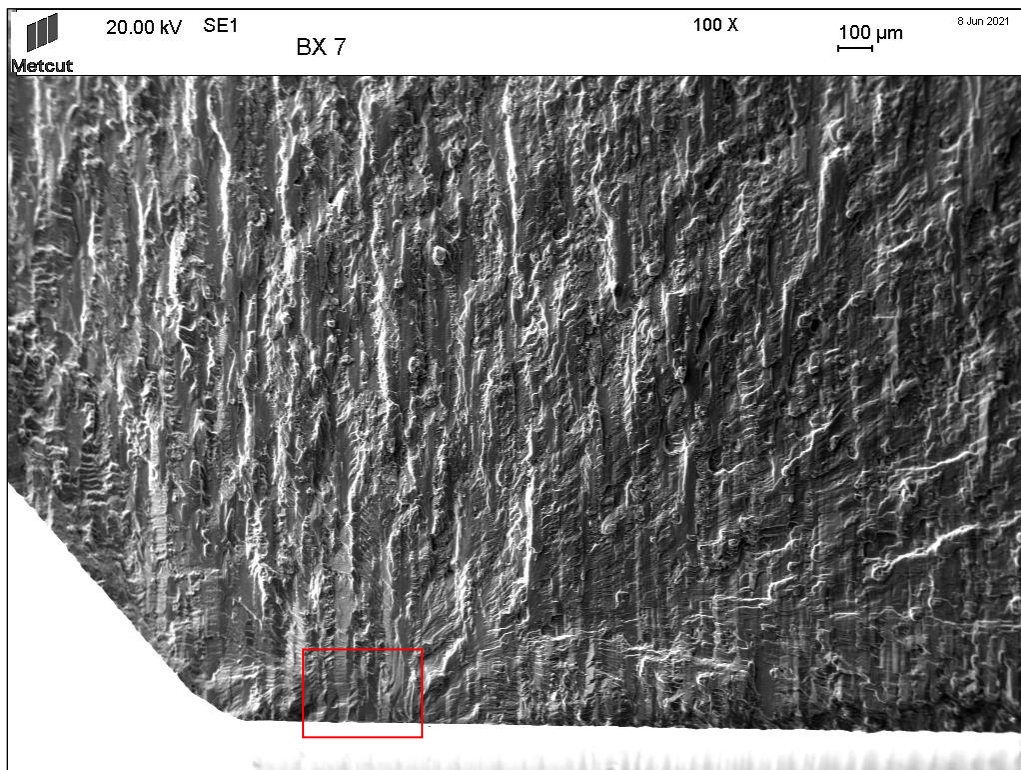
Figure 2. Fracture face of sample BX 7, Site 1 is viewed at intermediate magnification, (SEI mode, 0° tilt). A red box identifies the initiation site.

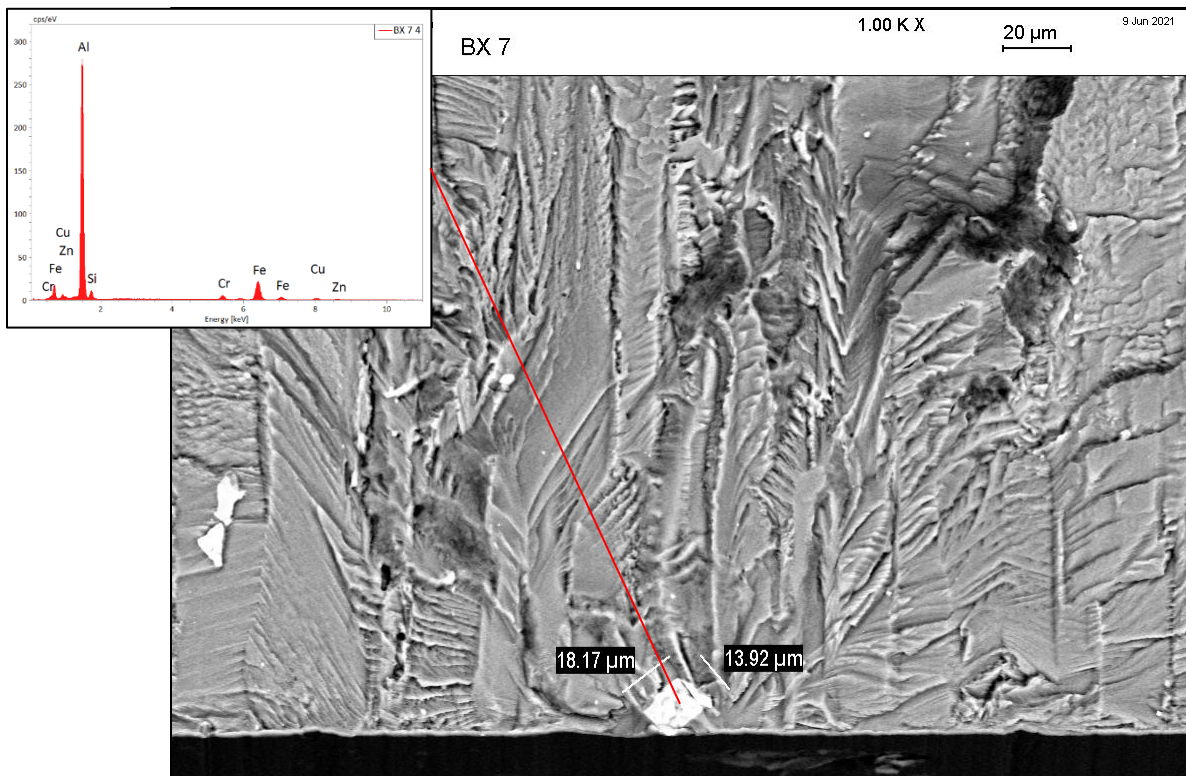
Figure 3. Initiation site for specimen BX 7, Site 1 is seen at higher magnification, (BEI mode, 0° tilt). Inclusion at the surface measuring 13.9 µm x 18.2 µm was observed at the initiation site. Inclusion contains mostly Aluminum with concentrations of Iron, Copper, Silicon, Chromium and Zinc.

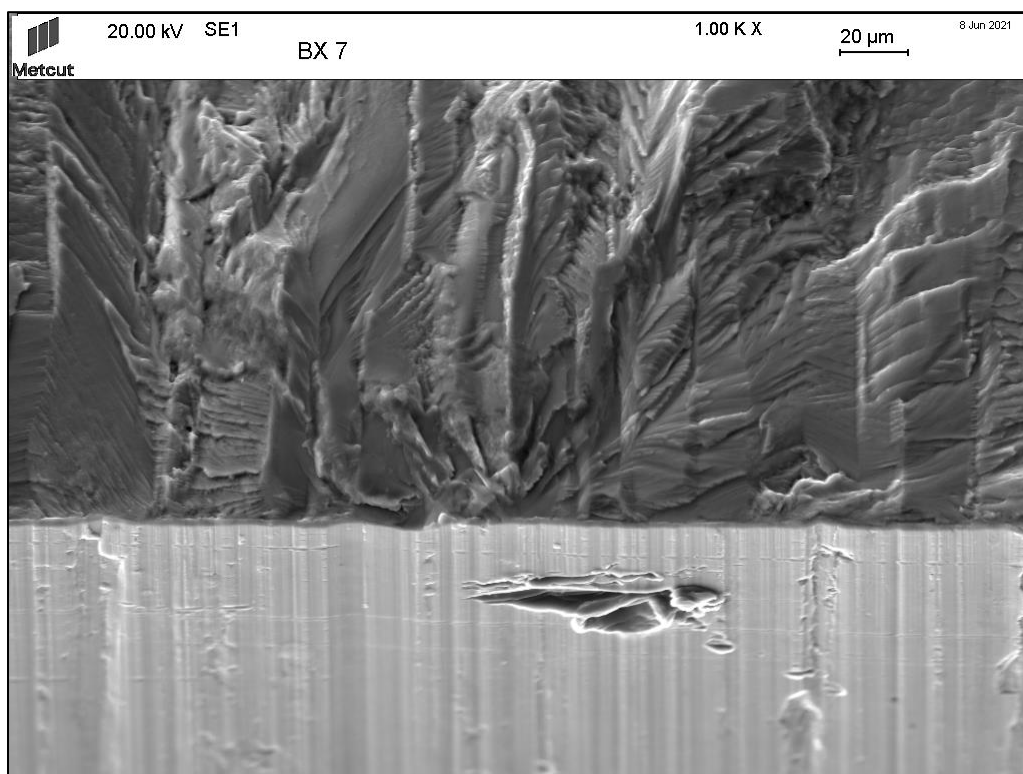
Figure 4. Initiation site for specimen BX 7, Site 1 is seen at higher magnification, (SEI mode, 15° tilt).

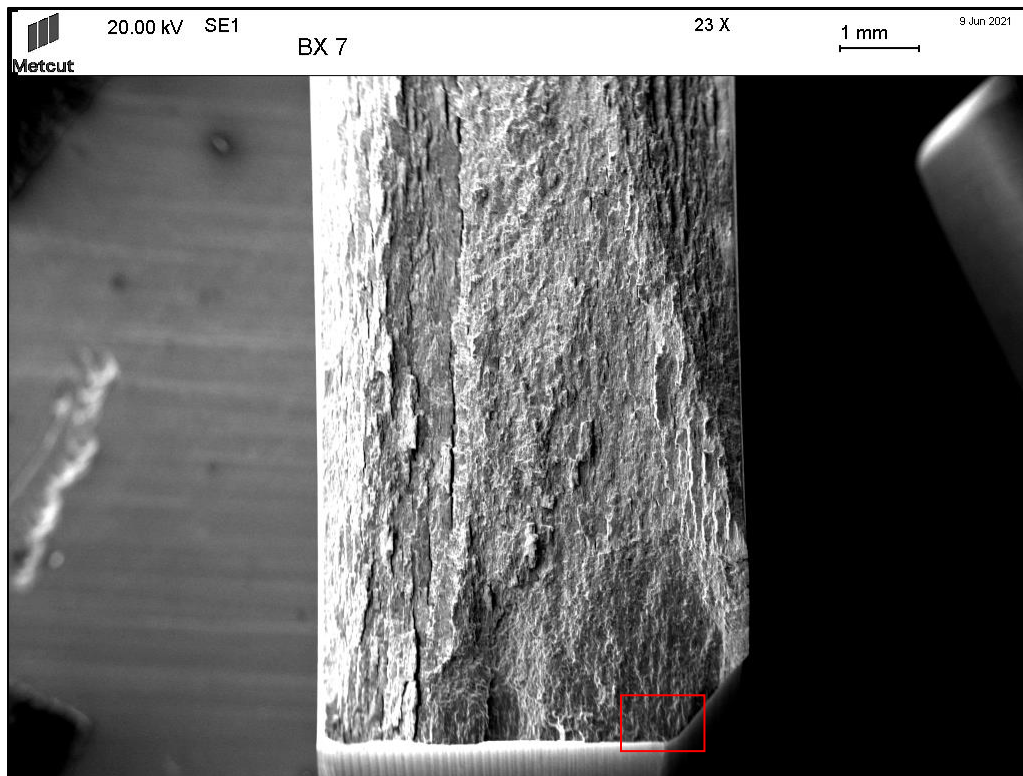
Figure 5. Fracture face of sample BX 7, Site 2 is shown at low magnification, (SEI mode, 0° tilt). The red box identifies the initiation site.

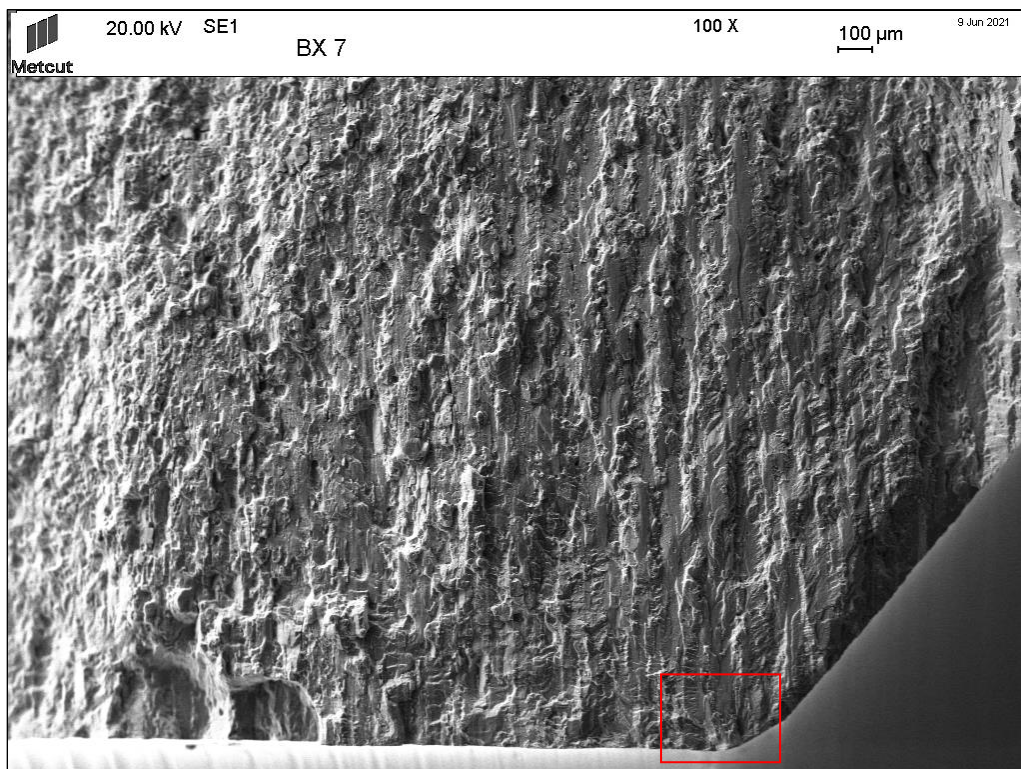
Figure 6. Fracture face of sample BX 7, Site 2 is viewed at intermediate magnification, (SEI mode, 0° tilt). A red box identifies the initiation site.

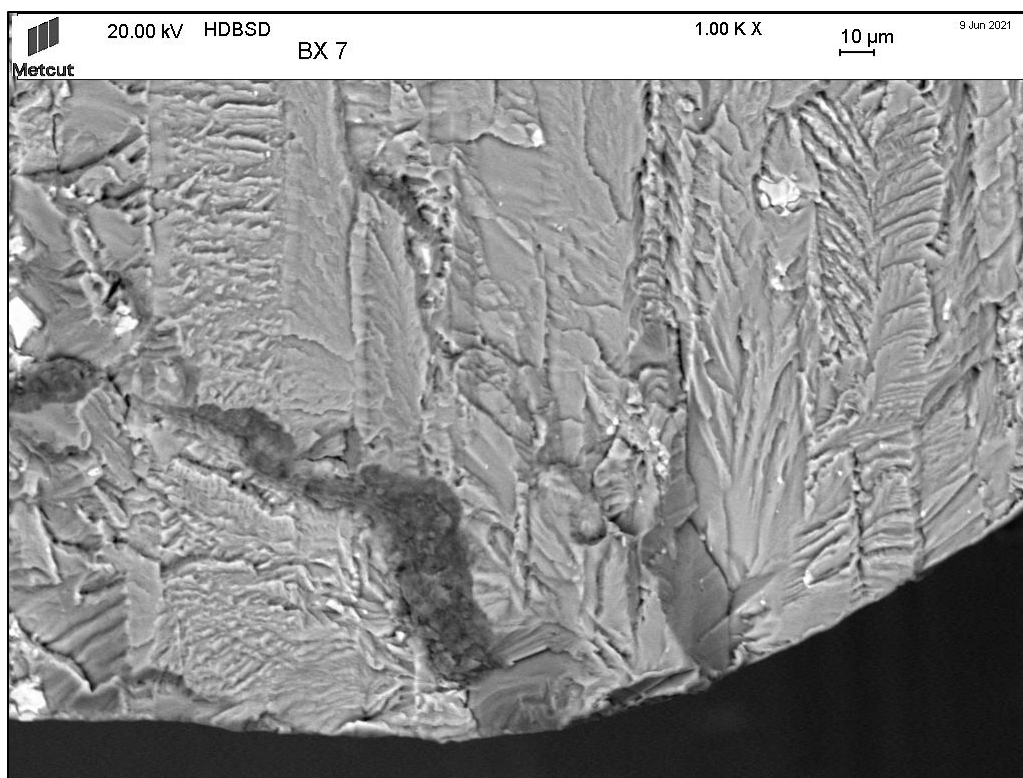
Figure 7. Initiation site for specimen BX 7, Site 2 is seen at higher magnification, (BEI mode, 0° tilt). Grain failure at the surface was observed at the initiation site.

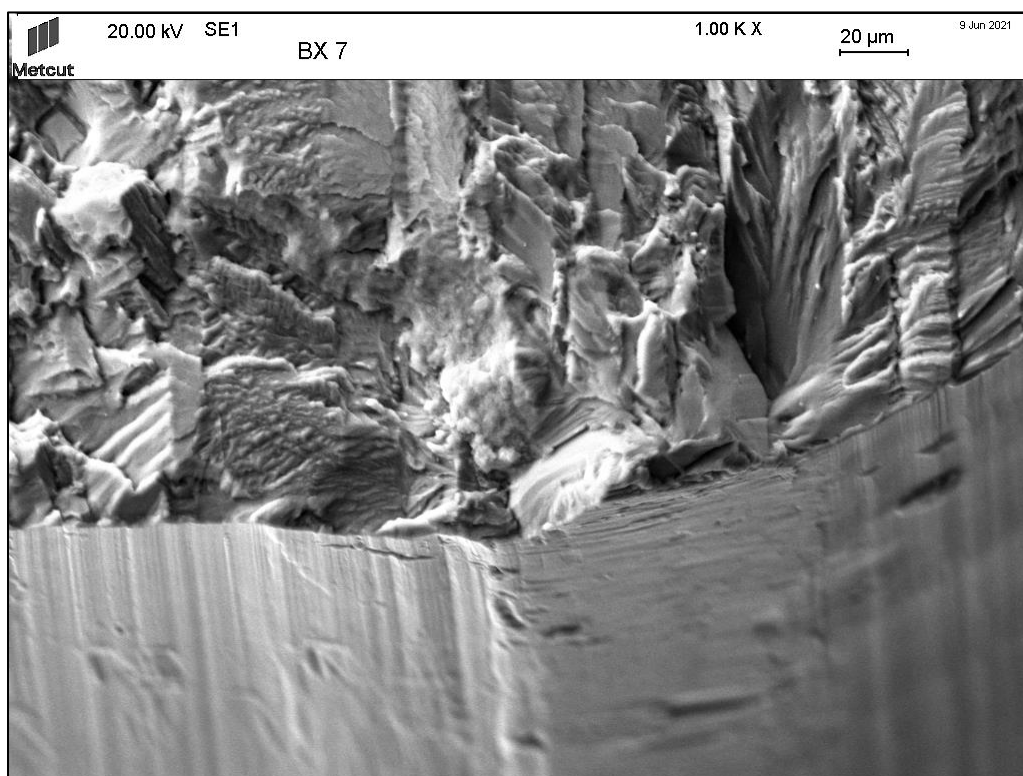
Figure 8. Initiation site for specimen BX 7, Site 2 is seen at higher magnification, (SEI mode, 15° tilt).

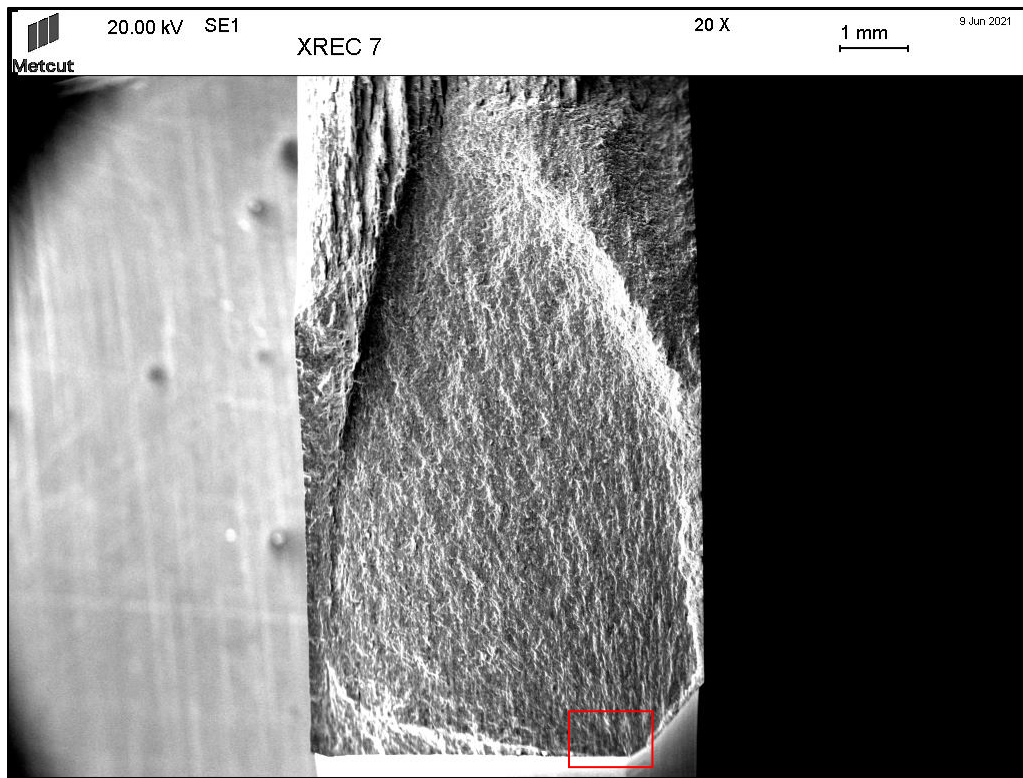
Figure 9. Fracture face of sample XREC 7, Site 1 is shown at low magnification, (SEI mode, 0° tilt). The red box identifies the initiation site.

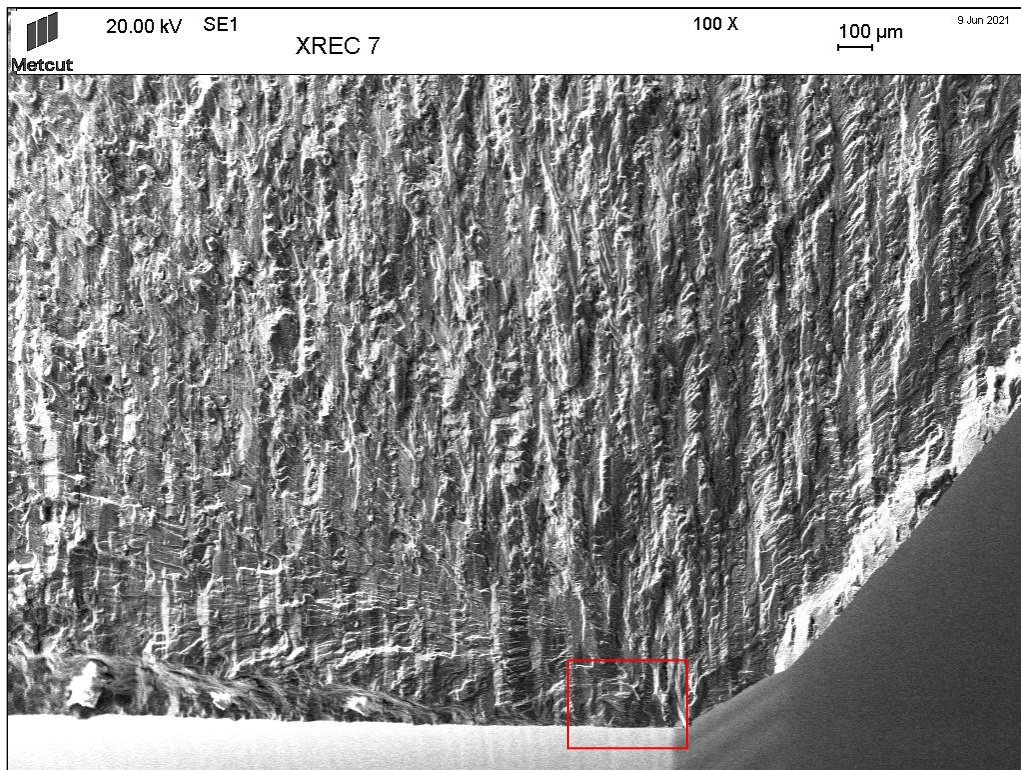
Figure 10. Fracture face of sample XREC 7, Site 1 is viewed at intermediate magnification, (SEI mode, 0° tilt). A red box identifies the initiation site.

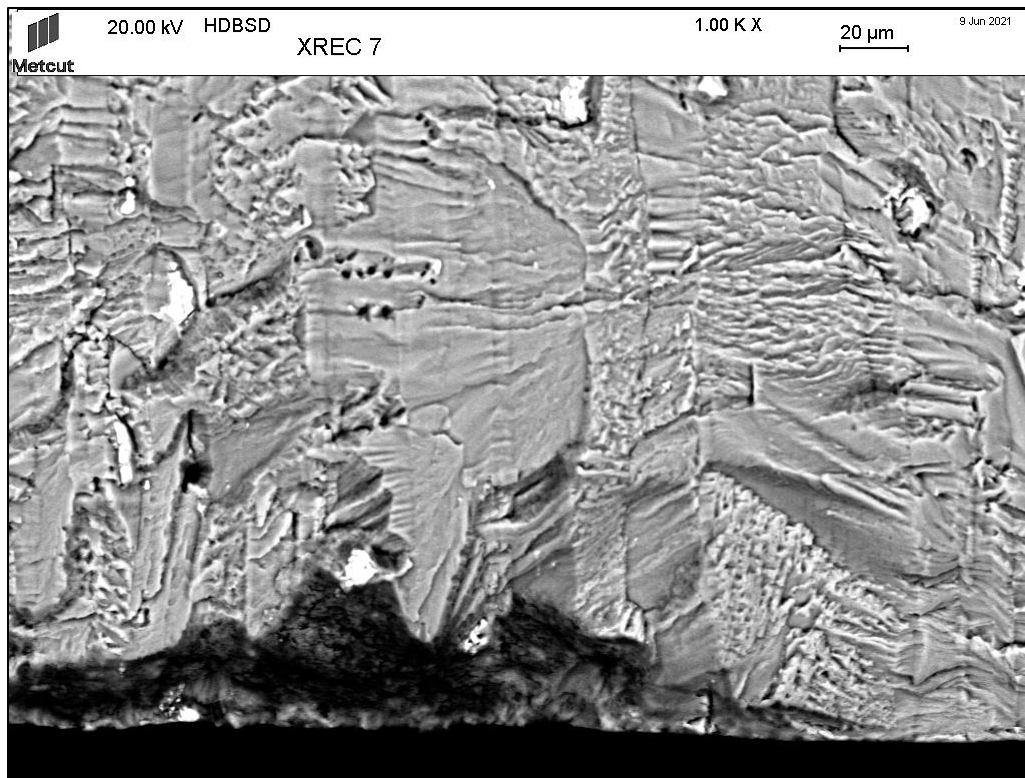
Figure 11. Initiation site for specimen XREC 7, Site 1 is seen at higher magnification, (BEI mode, 0° tilt). Grain failure near the surface was observed at the initiation site.

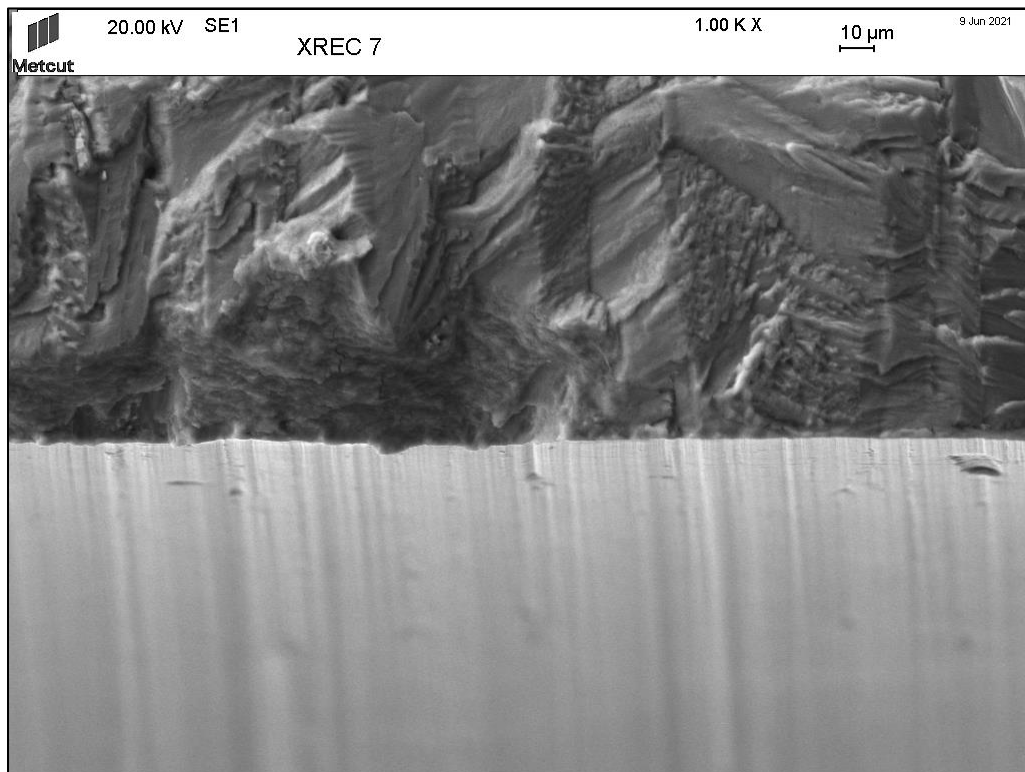
Figure 12. Initiation site for specimen XREC 7, Site 1 is seen at higher magnification, (SEI mode, 15° tilt).

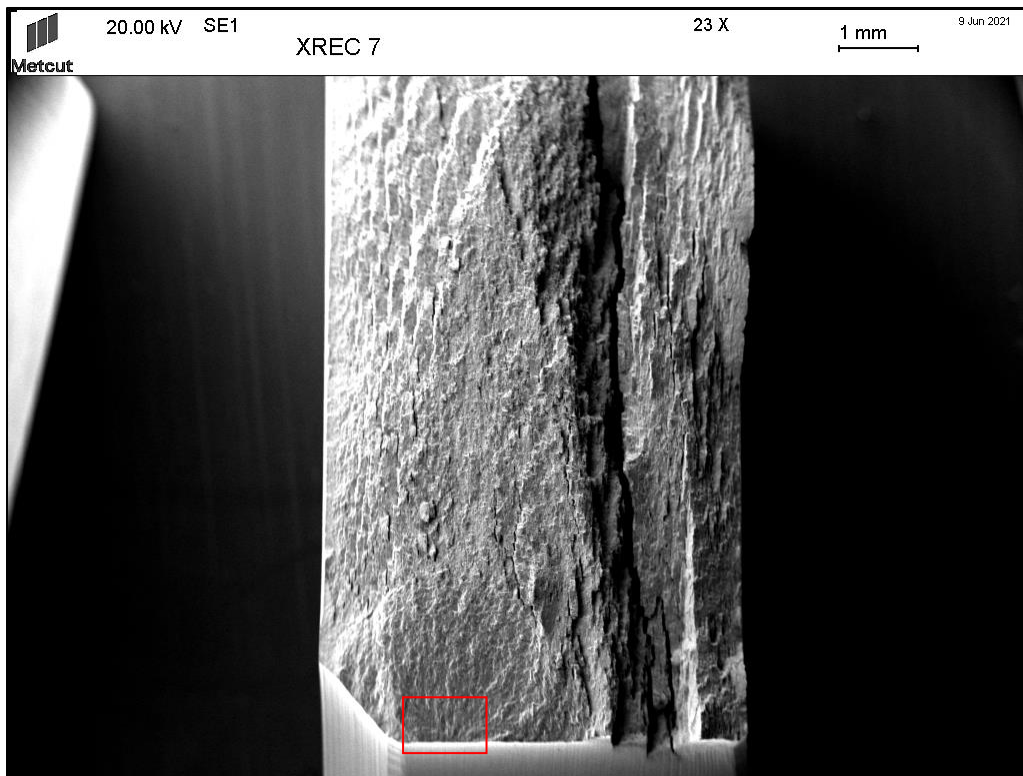
Figure 13. Fracture face of sample XREC 7, Site 2 is shown at low magnification, (SEI mode, 0° tilt). The red box identifies the initiation site.

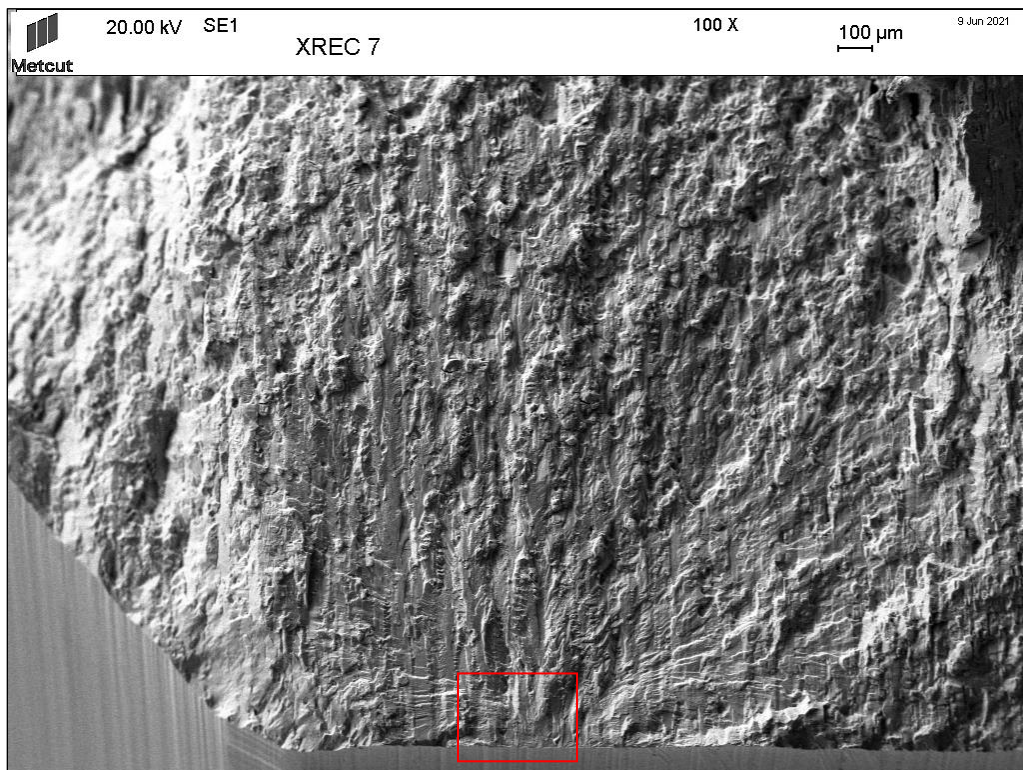
Figure 14. Fracture face of sample XREC 7, Site 2 is viewed at intermediate magnification, (SEI mode, 0° tilt). A red box identifies the initiation site.

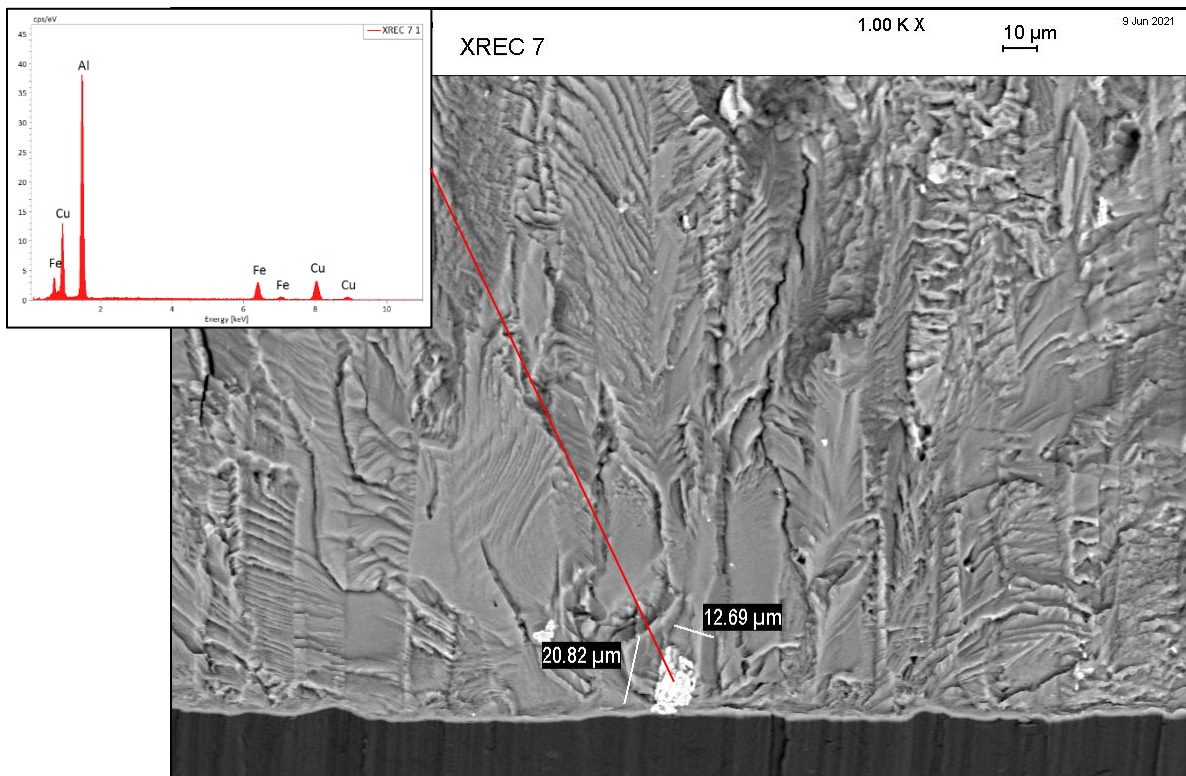
Figure 15. Initiation site for specimen XREC 7, Site 2 is seen at higher magnification, (BEI mode, 0° tilt). Inclusion at the surface measuring 12.7 μm x 20.8 μm was observed at the initiation site. Inclusion contains mostly Aluminum with concentrations of Iron and Copper.

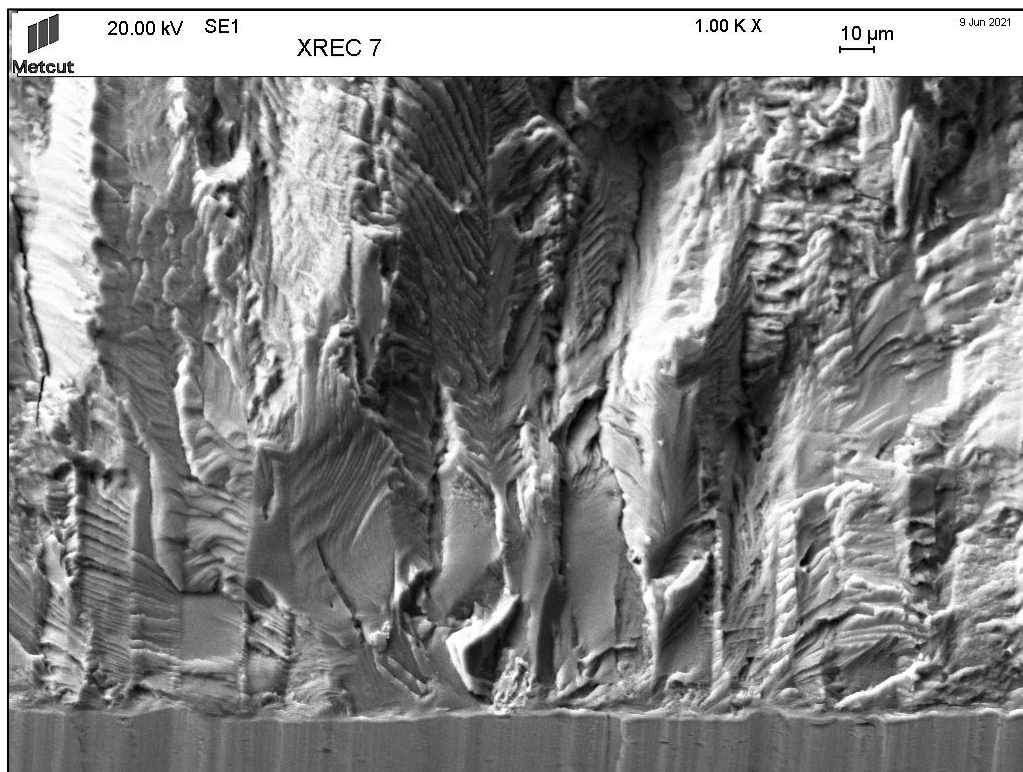
Figure 16. Initiation site for specimen XREC 7, Site 2 is seen at higher magnification, (SEI mode, 0° tilt).
