LABORATORY REPORT

PROJECT NO.: 6032-106782-1
REVISION NO.: 1
DATE: June 25, 2021
Original Date: June 21, 2021
AUTHORIZATION: P1367-SBIR

PROJECT: Per customer's request, Metcut Research Inc. sectioned, mounted, polished, etched, and analyzed the supplied specimens, see Figure 1.

1. Metallographic evaluation of EDM cut surfaces.

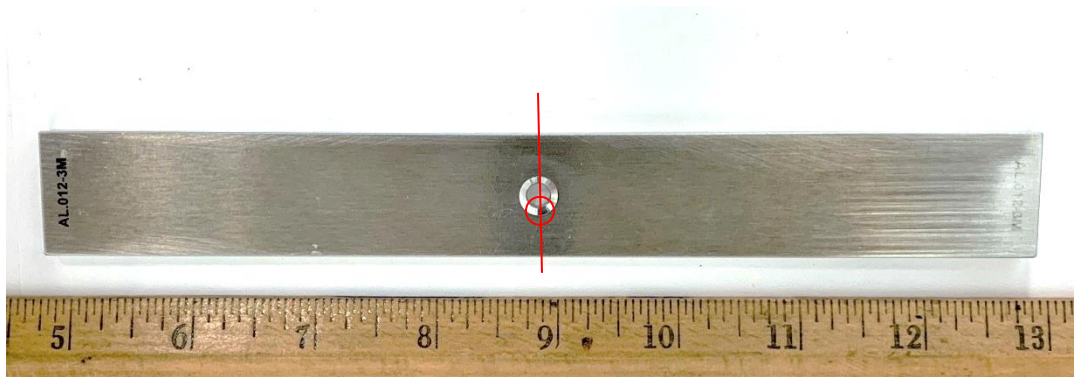
**FIGURE 1.** Representative example of EDM samples received for analysis. Red line shows sectioning location. Red circle shows area of interest shown in photomicrographs.

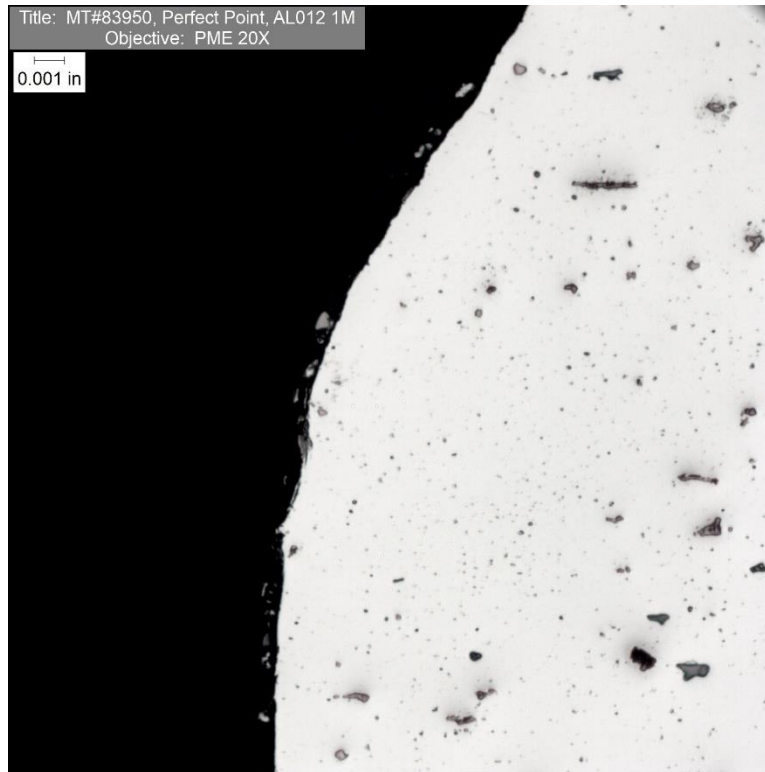
FIGURE 2. MRI Mount No.: 83950. Typical microstructure of the supplied sample AL.012 1M is presented in the unetched condition showing the full EDM cut area. No cracking observed. 200X magnification.

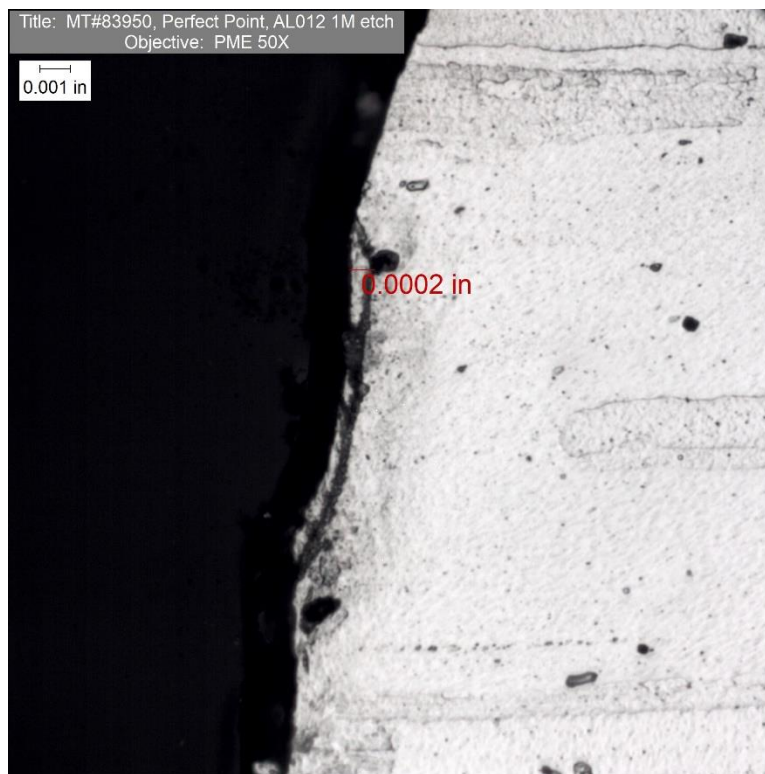
FIGURE 3. MRI Mount No.: 83950. Microstructure of the supplied sample AL.012 1M is presented in the etched condition showing EDM cut with thickest recast layer observed, 500X magnification, Keller's etch.

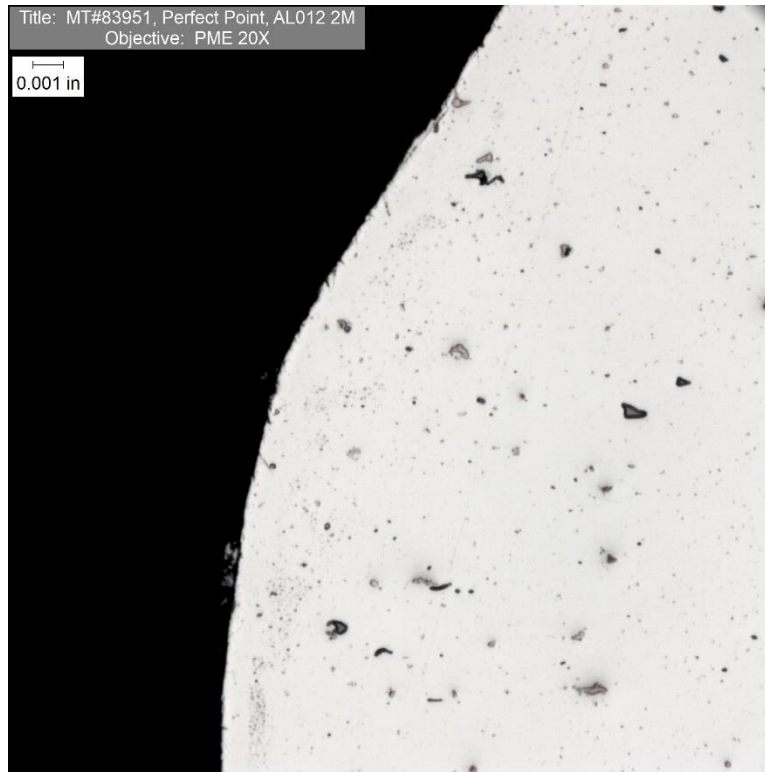
FIGURE 4. MRI Mount No.: 83951. Typical microstructure of the supplied sample AL.012 2M is presented in the unetched condition showing the full EDM cut area. No cracking observed. 200X magnification.

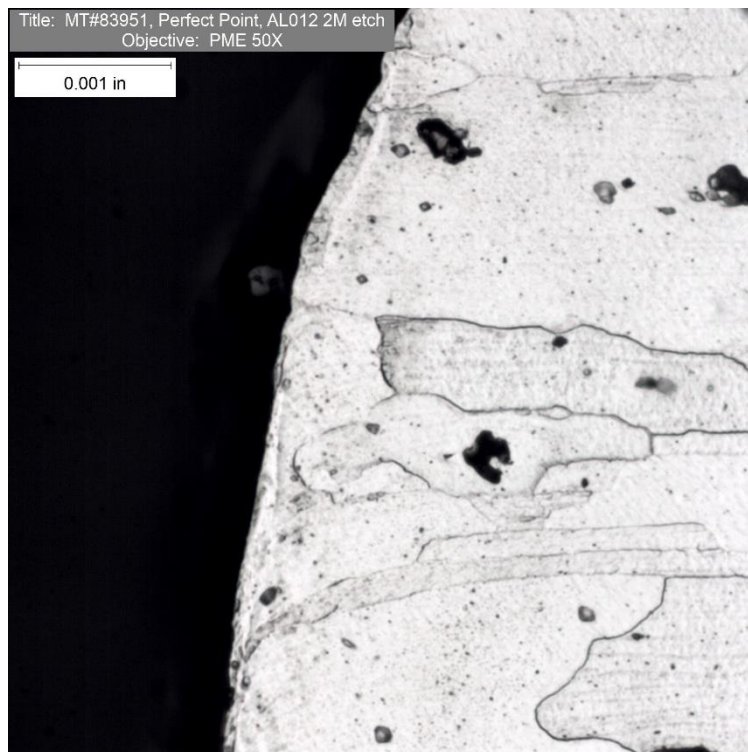
FIGURE 5. MRI Mount No.: 83951. Microstructure of the supplied sample AL.012 2M is presented in the etched condition showing EDM cut. No recast layer was observed. 500X magnification, Keller's etch.

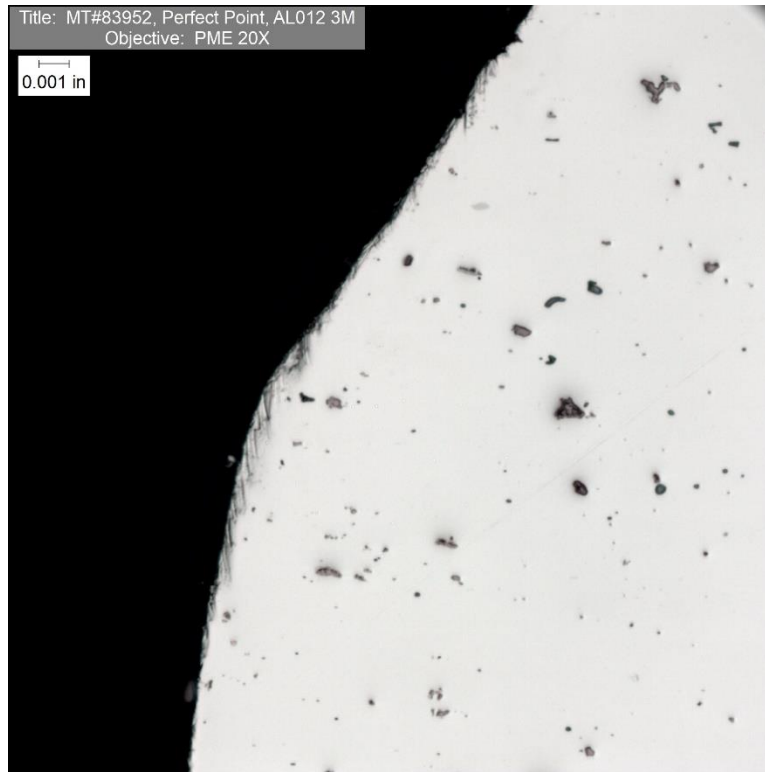
FIGURE 6. MRI Mount No.: 83952. Typical microstructure of the supplied sample AL.012 3M is presented in the unetched condition showing the full EDM cut area. No cracking observed. 200X magnification.

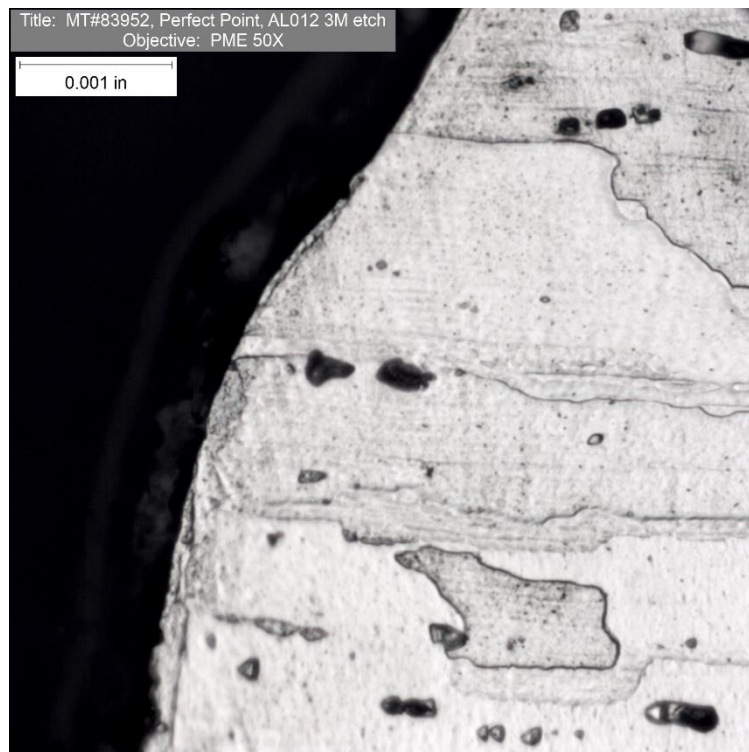
FIGURE 7. MRI Mount No.: 83952. Microstructure of the supplied sample AL.012 3M is presented in the etched condition showing EDM cut. No recast layer was observed. 500X magnification, Keller's etch.

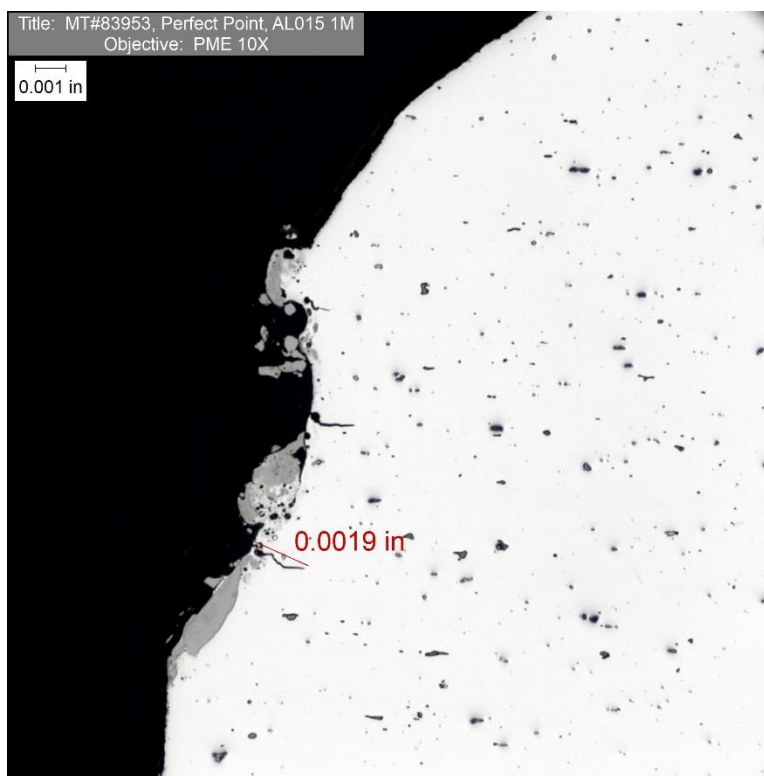
FIGURE 8. MRI Mount No.: 83953. Typical microstructure of the supplied sample AL.015 1M is presented in the unetched condition showing the full EDM cut area. Cracking was observed. 100X magnification.

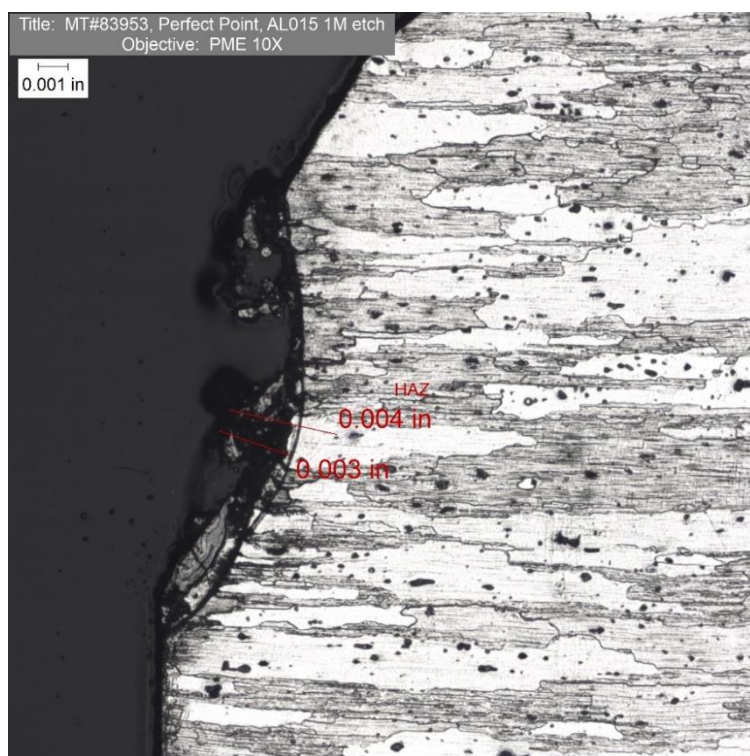
FIGURE 9. MRI Mount No.: 83953. Microstructure of the supplied sample AL.015 1M is presented in the etched condition showing EDM cut with thickest recast layer and HAZ observed, 100X magnification, Keller's etch.

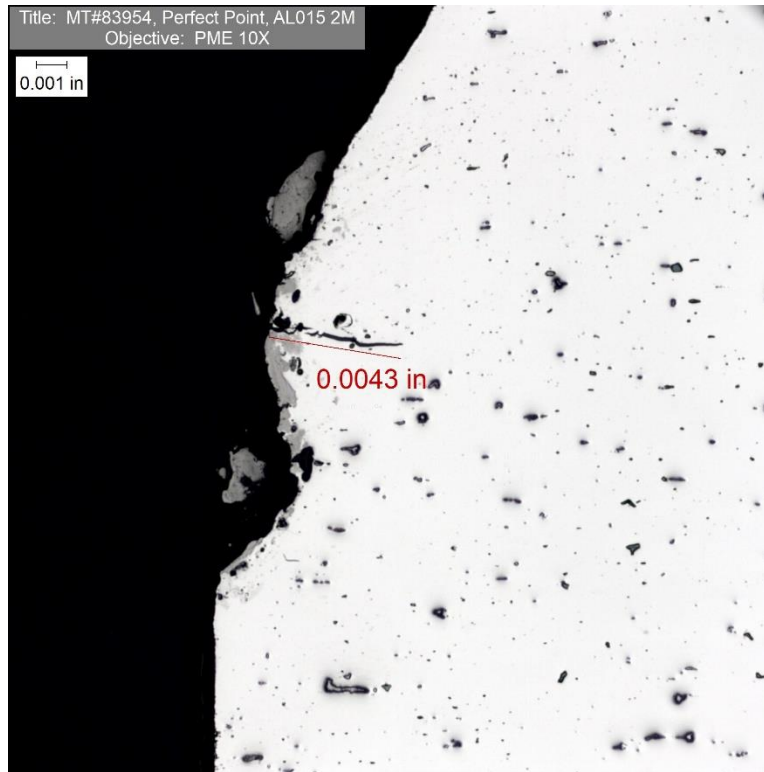
FIGURE 10. MRI Mount No.: 83954. Typical microstructure of the supplied sample AL.015 2M is presented in the unetched condition showing the full EDM cut area. Cracking was observed. 100X magnification.

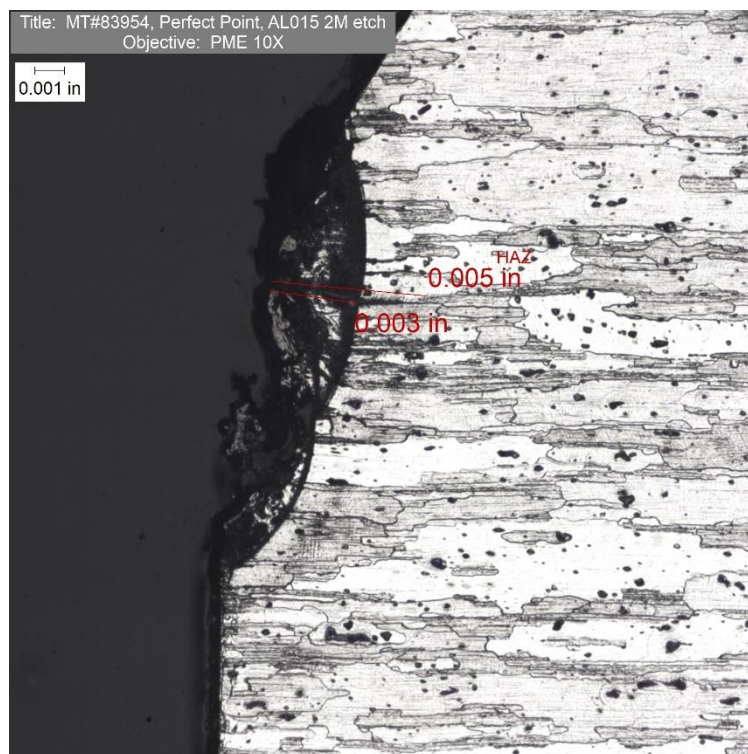
FIGURE 11. MRI Mount No.: 83954. Microstructure of the supplied sample AL.015 2M is presented in the etched condition showing EDM cut with thickest recast layer and HAZ observed, 100X magnification, Keller's etch.

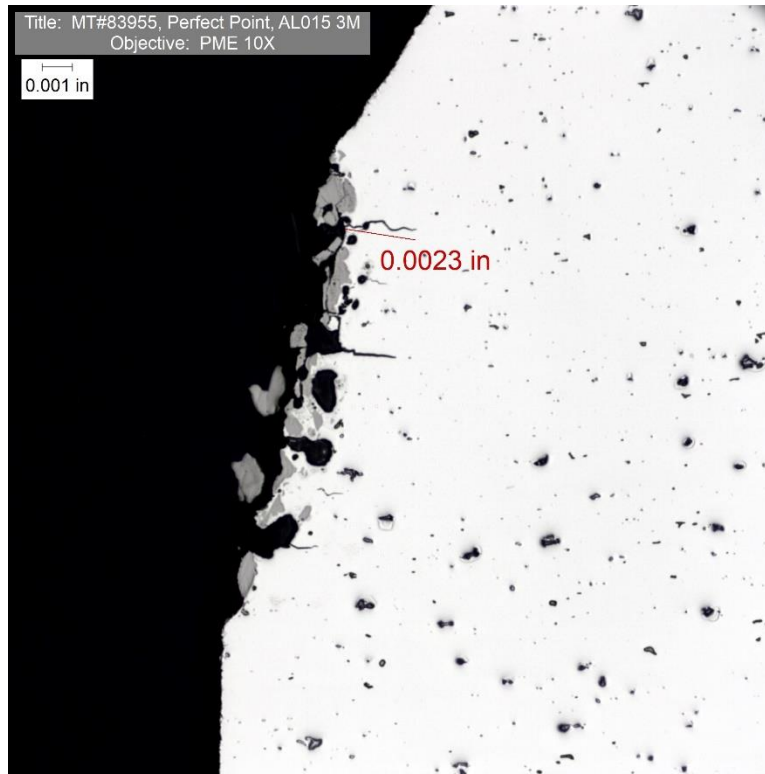
FIGURE 12. MRI Mount No.: 83955. Typical microstructure of the supplied sample AL.015 3M is presented in the unetched condition showing the full EDM cut area. Cracking was observed. 100X magnification.

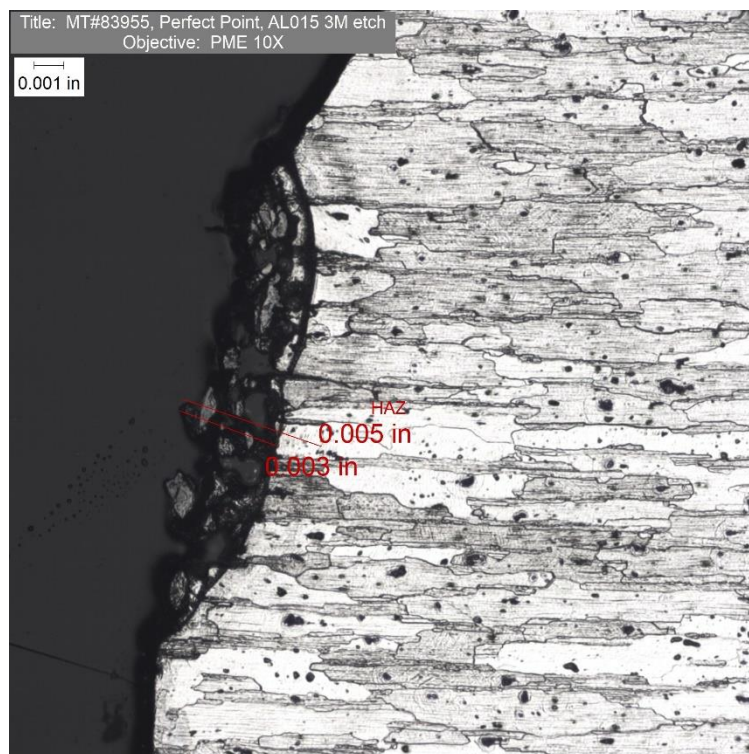
FIGURE 13. MRI Mount No.: 83955. Microstructure of the supplied sample AL.015 3M is presented in the etched condition showing EDM cut with thickest recast layer and HAZ observed, 100X magnification, Keller's etch.

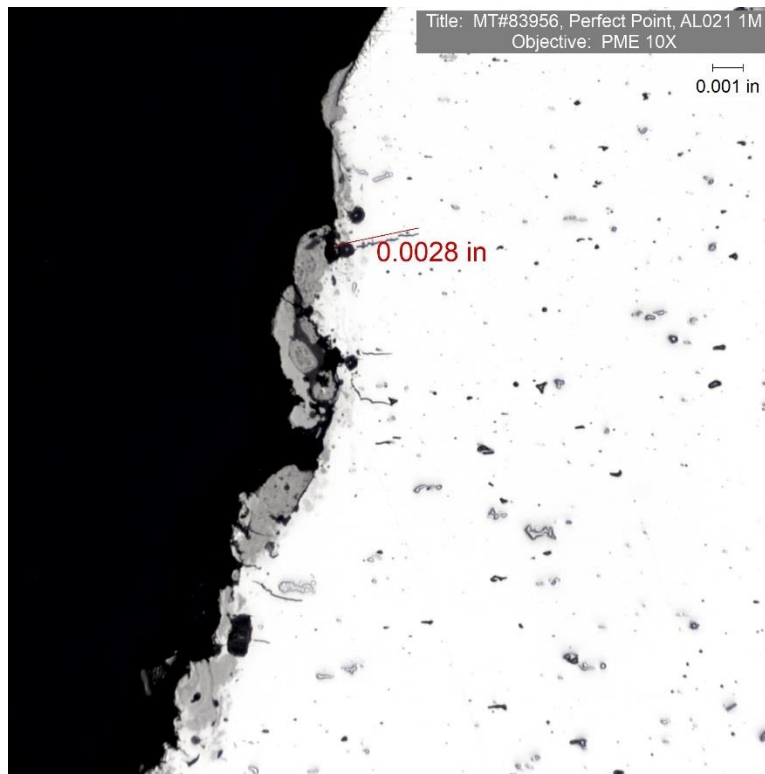
FIGURE 14. MRI Mount No.: 83956. Typical microstructure of the supplied sample AL.021 1M is presented in the unetched condition showing the full EDM cut area. Cracking was observed. 100X magnification.

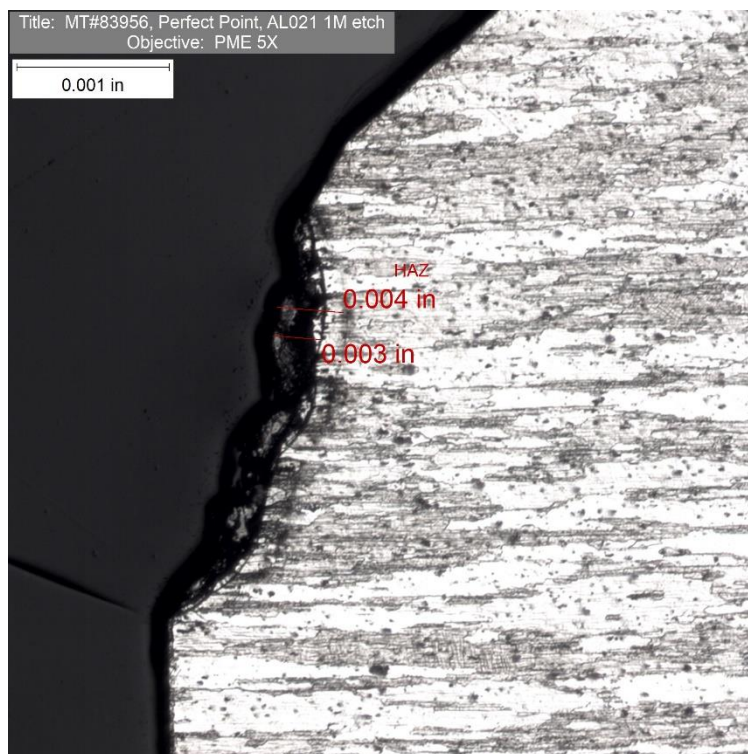
FIGURE 15. MRI Mount No.: 83956. Microstructure of the supplied sample AL.021 1M is presented in the etched condition showing EDM cut with thickest recast layer and HAZ observed, 50X magnification, Keller's etch.

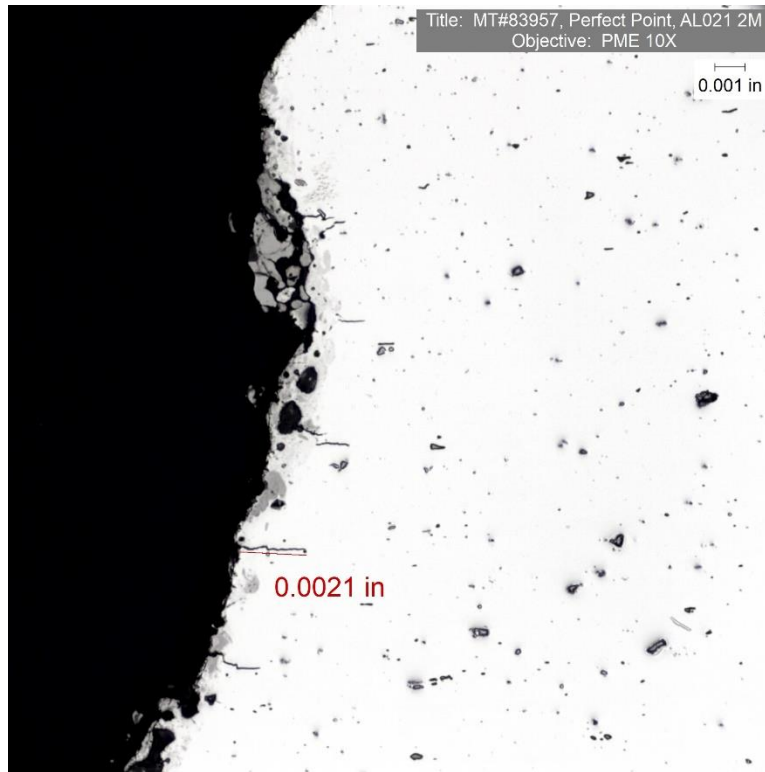
FIGURE 16. MRI Mount No.: 83957. Typical microstructure of the supplied sample AL.021 2M is presented in the unetched condition showing the full EDM cut area. Cracking was observed. 100X magnification.

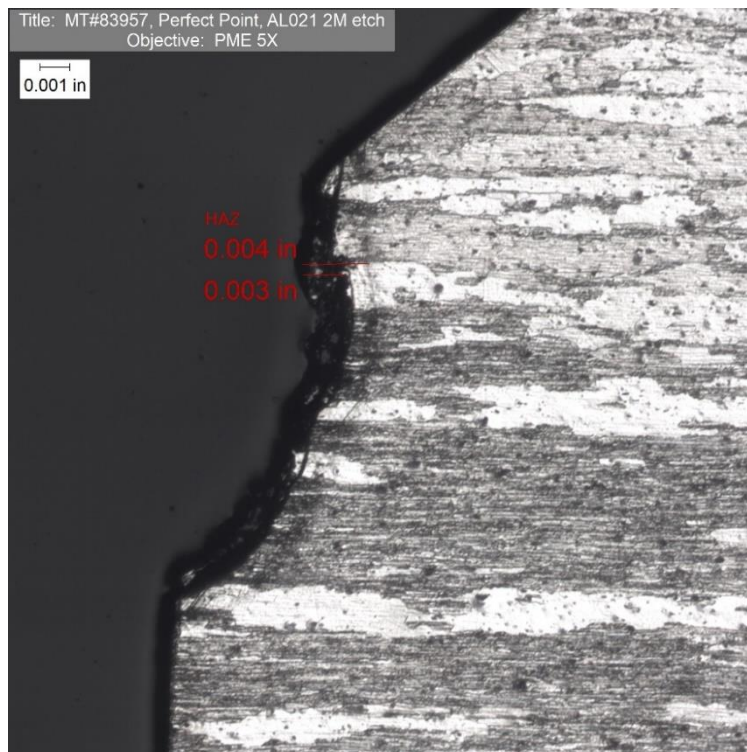
FIGURE 17. MRI Mount No.: 83957. Microstructure of the supplied sample AL.021 2M is presented in the etched condition showing EDM cut with thickest recast layer and HAZ observed, 50X magnification, Keller's etch.

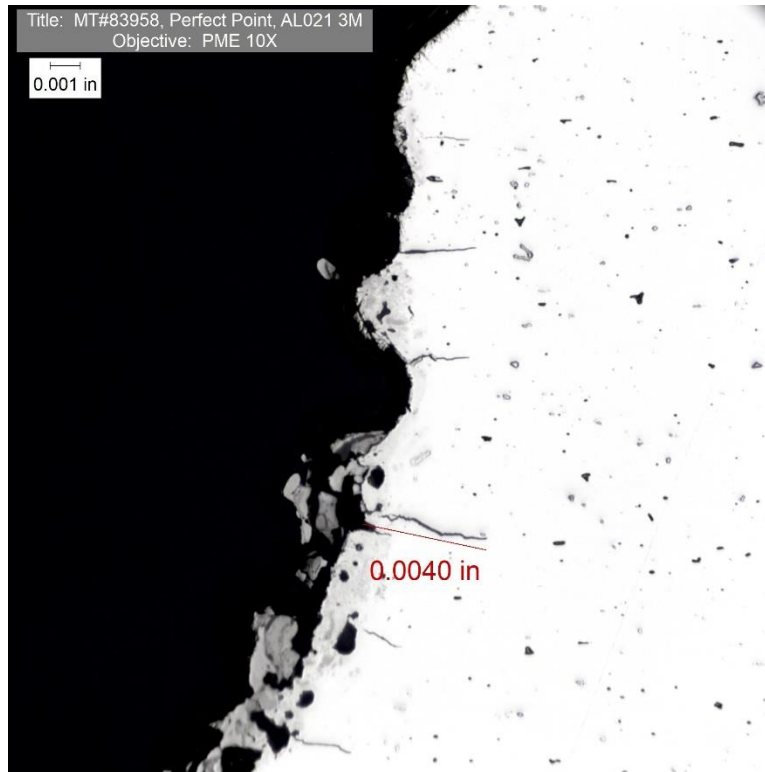
FIGURE 18. MRI Mount No.: 83958. Typical microstructure of the supplied sample AL.021 3M is presented in the unetched condition showing the full EDM cut area. Cracking was observed. 100X magnification.

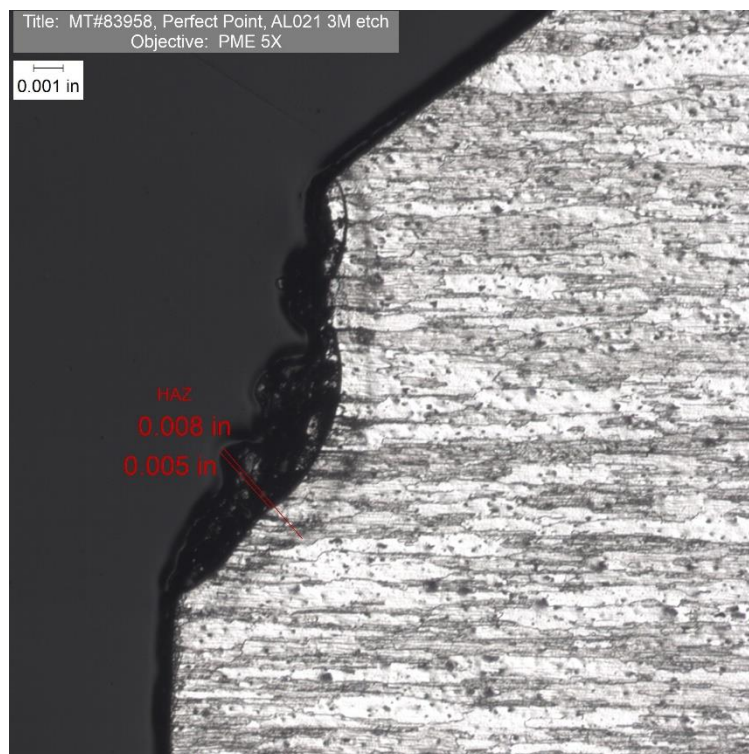
FIGURE 19. MRI Mount No.: 83958. Microstructure of the supplied sample AL.021 3M is presented in the etched condition showing EDM cut with thickest recast layer and HAZ observed, 50X magnification, Keller's etch.
