FRACTOGRAPHY REPORT GENERAL ANALYSIS OF SUPPLIED MATERIAL

TO: Perfect Point, Inc. ATTN: Mervyn Rudgley 15192 Triton Lane Huntington Beach, CA 92649 **PROJECT NO.:** 6032-106551-4 **REVISION NO.:** 0 **DATE:** June 16, 2021 **AUTHORIZATION:** P1073-SBIR2

AL7075-T651 BY 14 and YREC 14 106551-1 Rev. 2

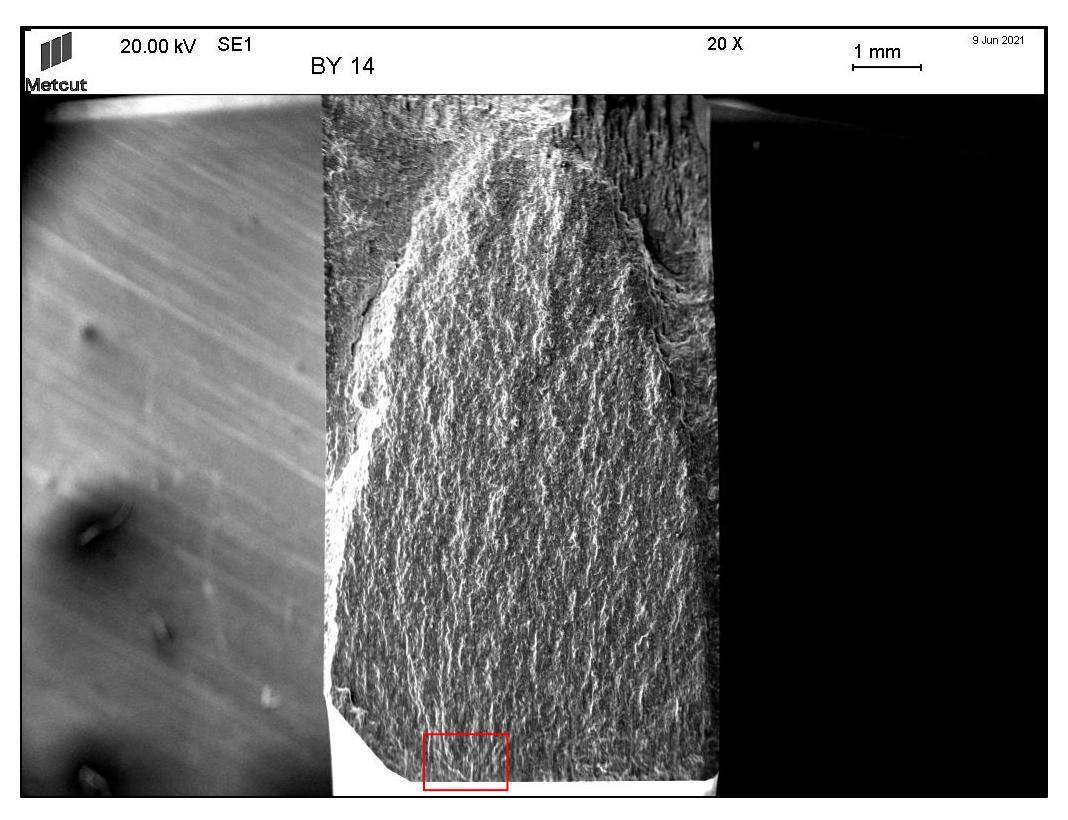
Figure 1. Fracture face of sample BY 14, Site 1 is shown at low magnification, (SEI mode, 0° tilt). The red box identifies the initiation site.

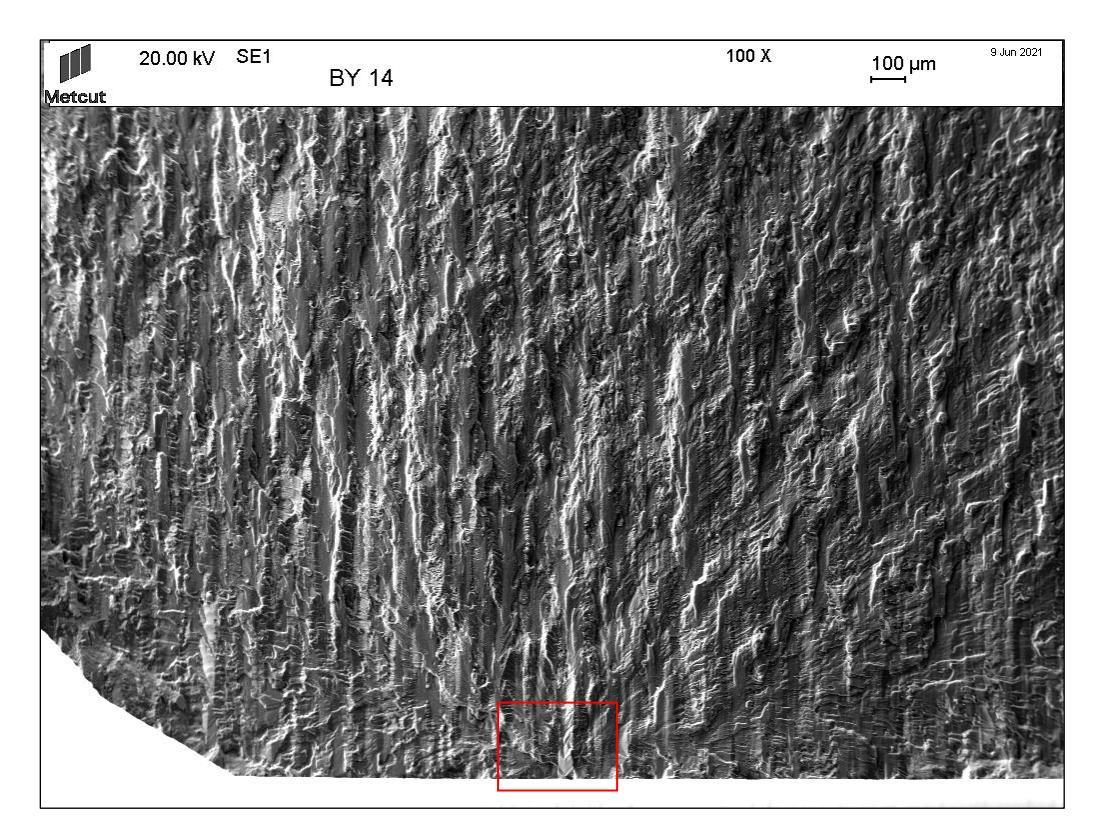
Figure 2. Fracture face of sample BY 14, Site 1 is viewed at intermediate magnification, (SEI mode, 0° tilt). A red box identifies the initiation site.

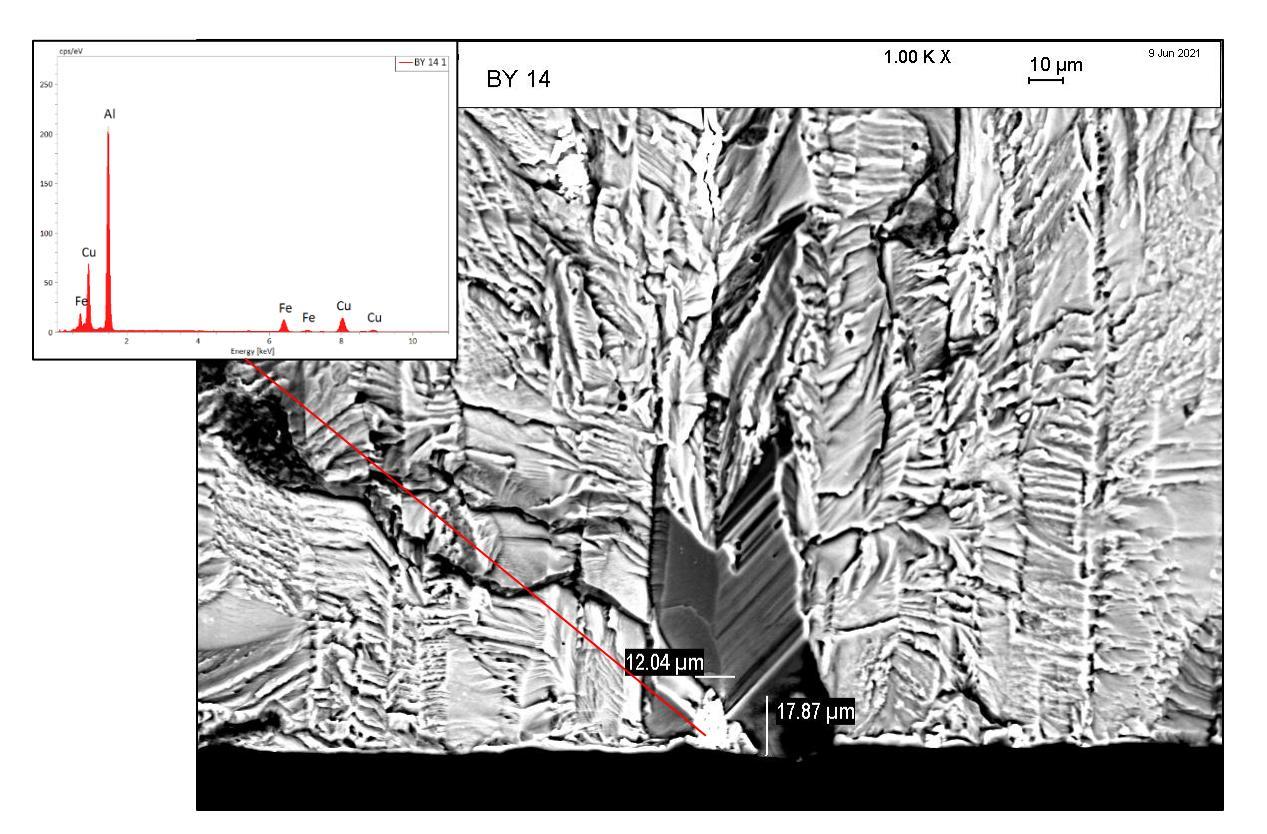
Figure 3. Initiation site for specimen BY 14, Site 1 is seen at higher magnification, (BEI mode, 0° tilt). Inclusion at the surface measuring 12.0 µm x 17.9 µm was observed as the only initiation site. Inclusion contains mostly Aluminum with concentrations of Iron and Copper.

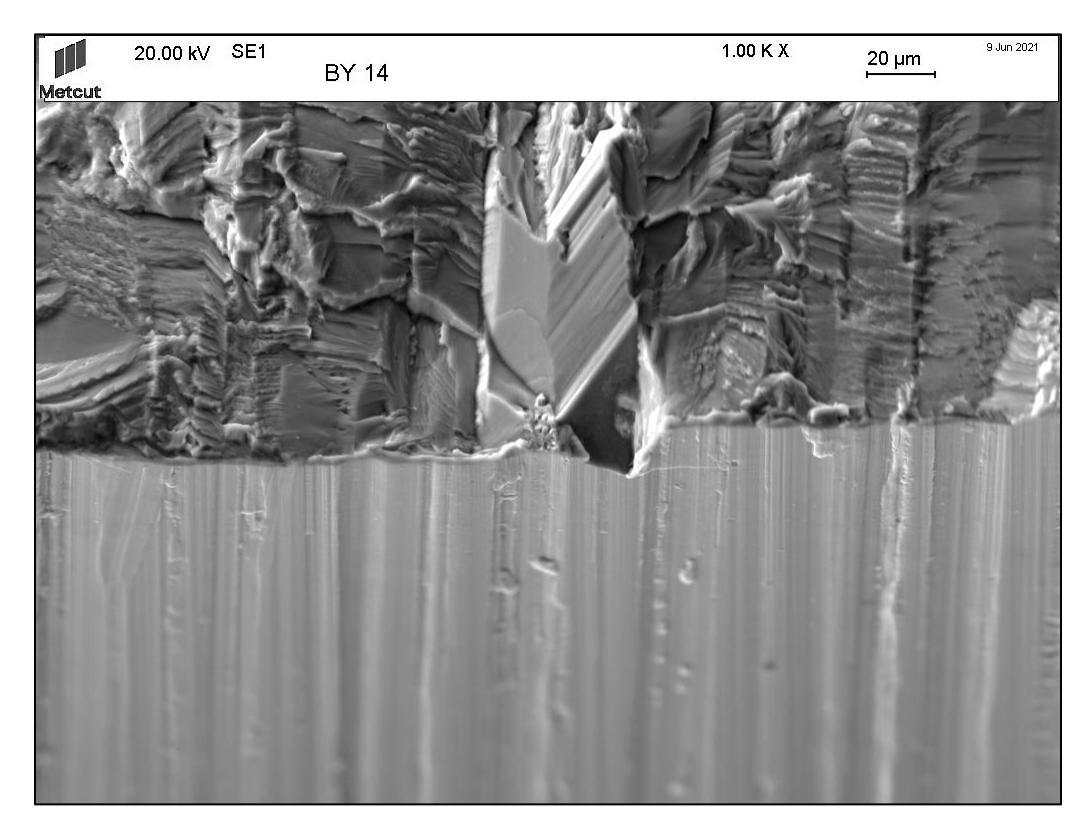
Figure 4. Initiation site for specimen BY 14, Site 1 is seen at higher magnification, (SEI mode, 15° tilt).

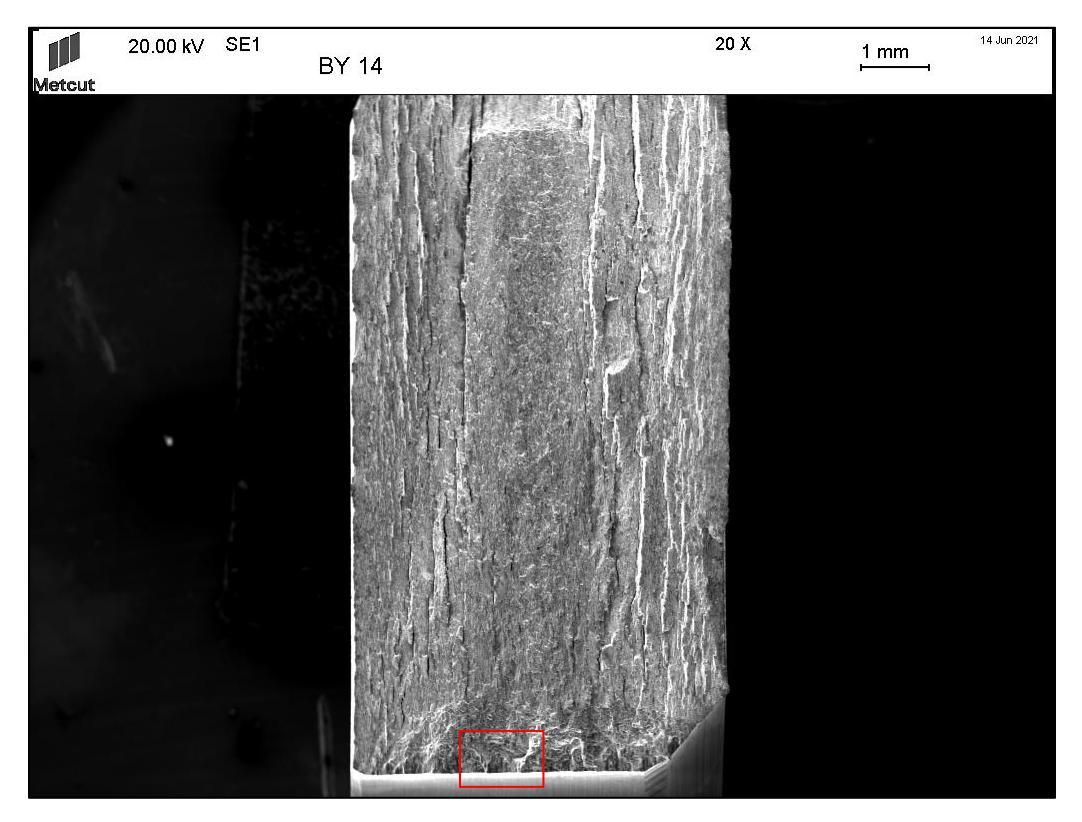
Figure 5. Fracture face of sample BY 14, Site 2 is shown at low magnification, (SEI mode, 0° tilt). The red box identifies the initiation site.

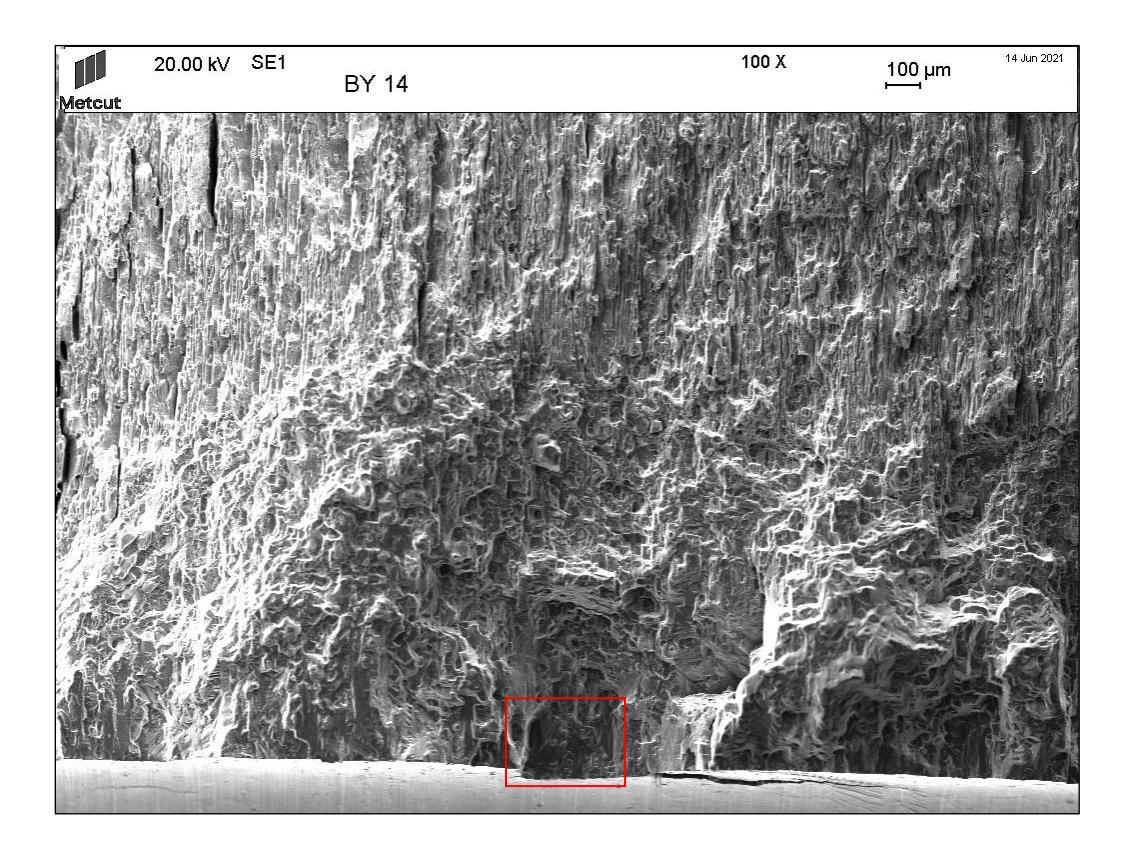
Figure 6. Fracture face of sample BY 14, Site 2 is viewed at intermediate magnification, (SEI mode, 0° tilt). A red box identifies the initiation site.

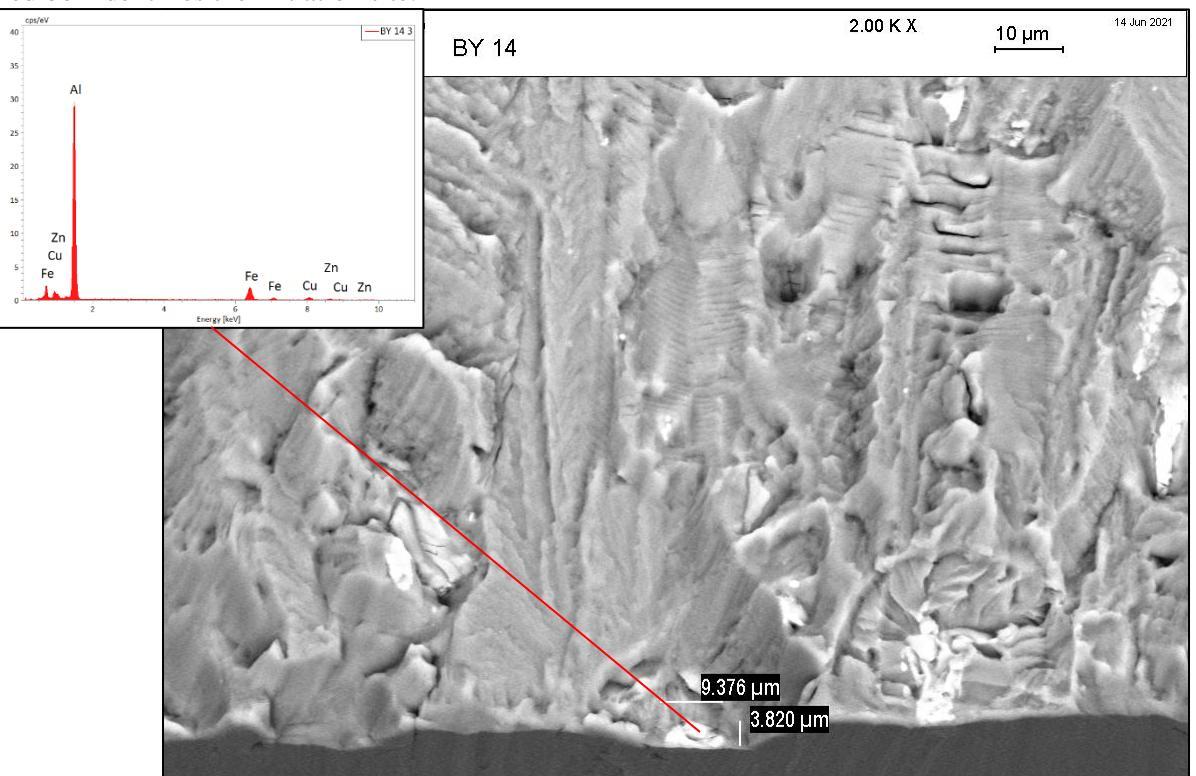
Figure 7. Initiation site for specimen BY 14, Site 2 is seen at higher magnification, (BEI mode, 0° tilt). Inclusion at the surface measuring 3.8 µm x 9.4 µm was observed as the only initiation site. Inclusion contains mostly Aluminum with concentrations of Iron, Copper and Zinc.

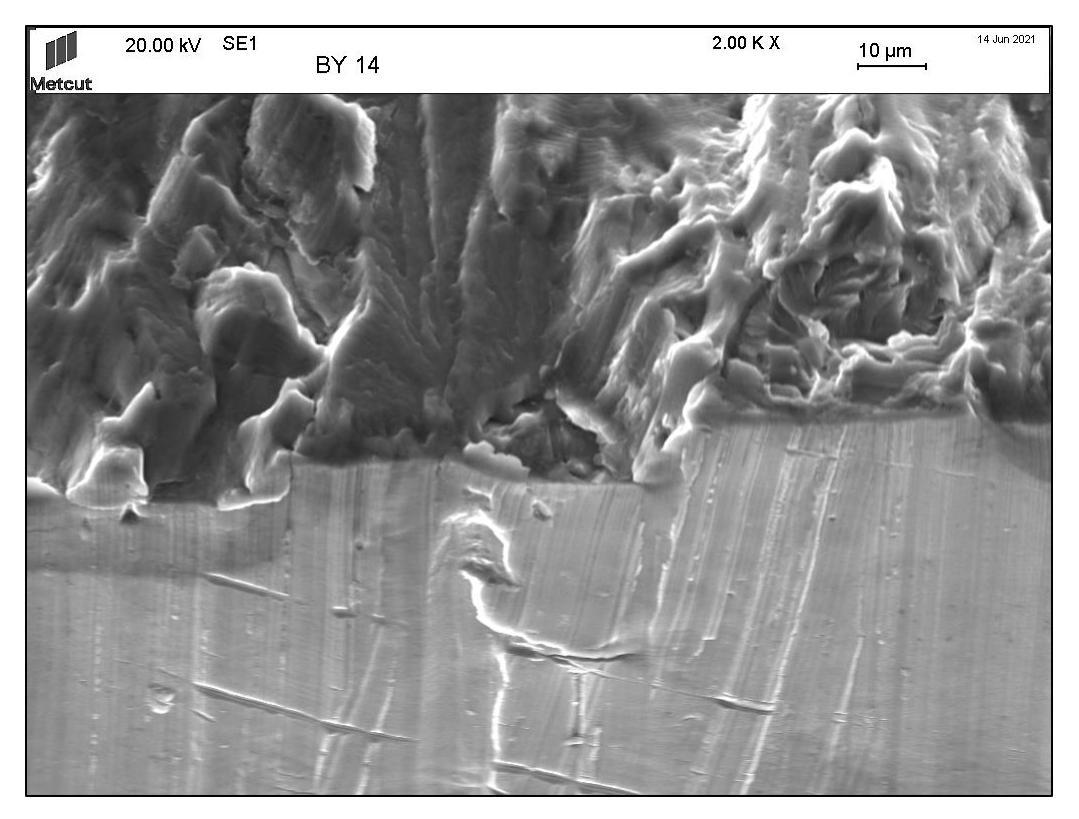
Figure 8. Initiation site for specimen BY 14, Site 2 is seen at higher magnification, (SEI mode, 15° tilt).

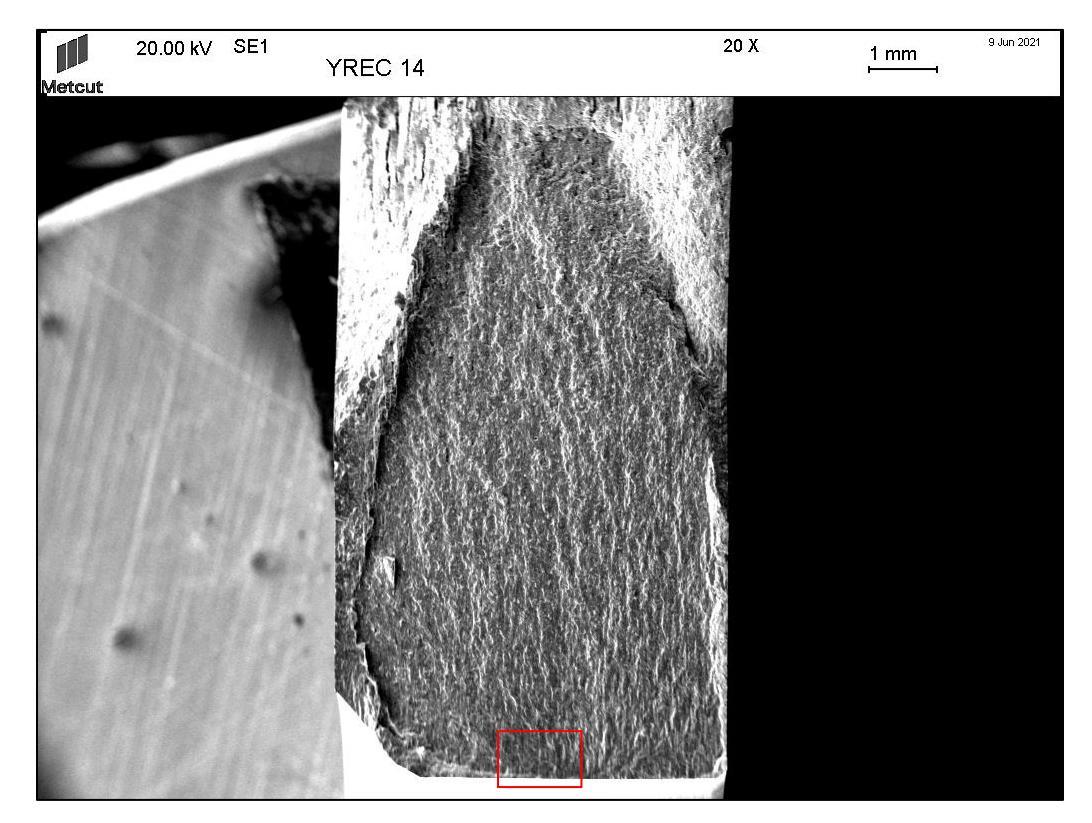
Figure 9. Fracture face of sample YREC 14, Site 1 is shown at low magnification, (SEI mode, 0° tilt). The red box identifies the initiation site.

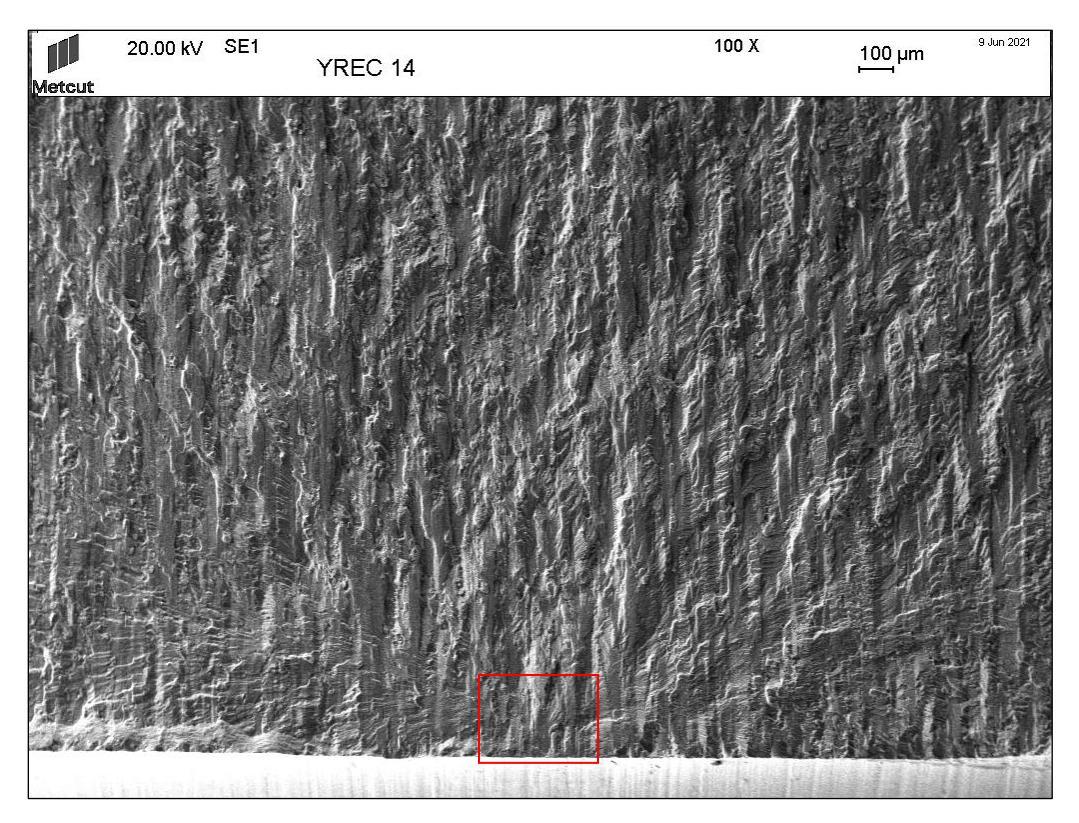
Figure 10. Fracture face of sample YREC 14, Site 1 is viewed at intermediate magnification, (SEI mode, 0° tilt). A red box identifies the initiation site.

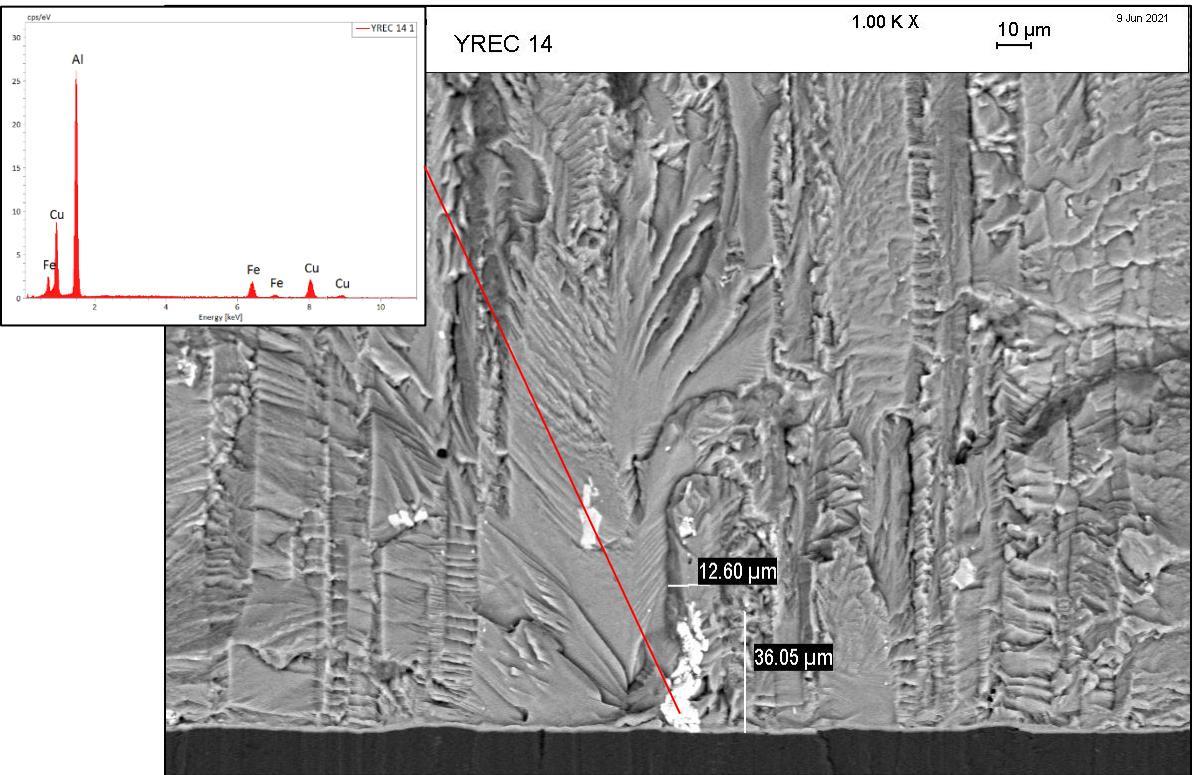
Figure 11. Initiation site for specimen YREC 14, Site 1 is seen at higher magnification, (BEI mode, 0° tilt). Inclusion at the surface measuring 12.6 µm x 36.1 µm was observed at the initiation site. Inclusion contains mostly Aluminum with concentrations of Iron and Copper.

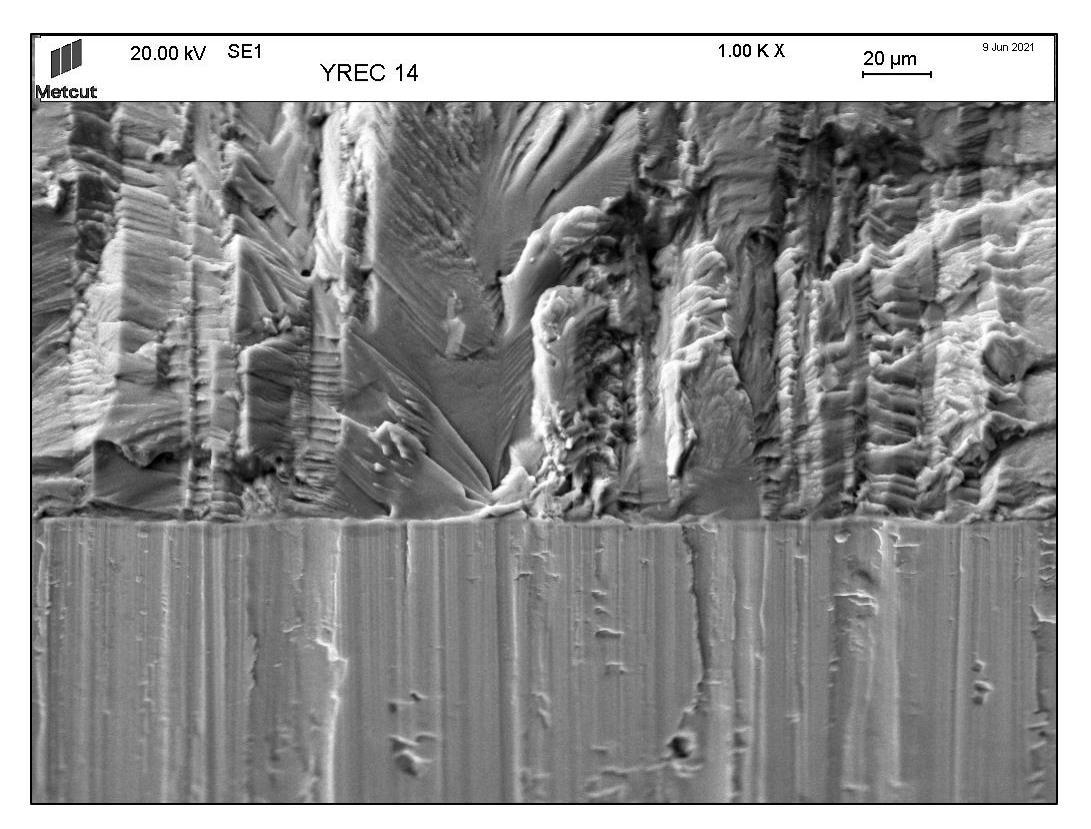
Figure 12. Initiation site for specimen YREC 14, Site 1 is seen at higher magnification, (SEI mode, 15° tilt).

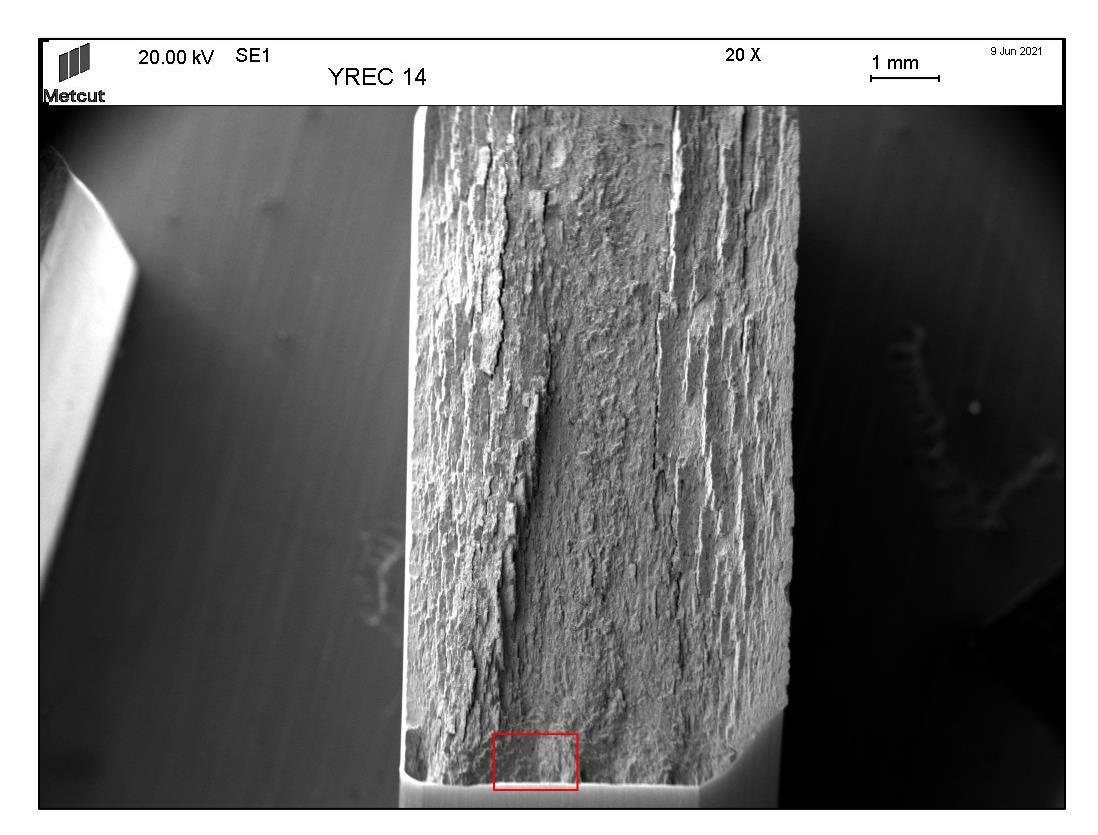
Figure 13. Fracture face of sample YREC 14, Site 2 is shown at low magnification, (SEI mode, 0° tilt). The red box identifies the initiation site.

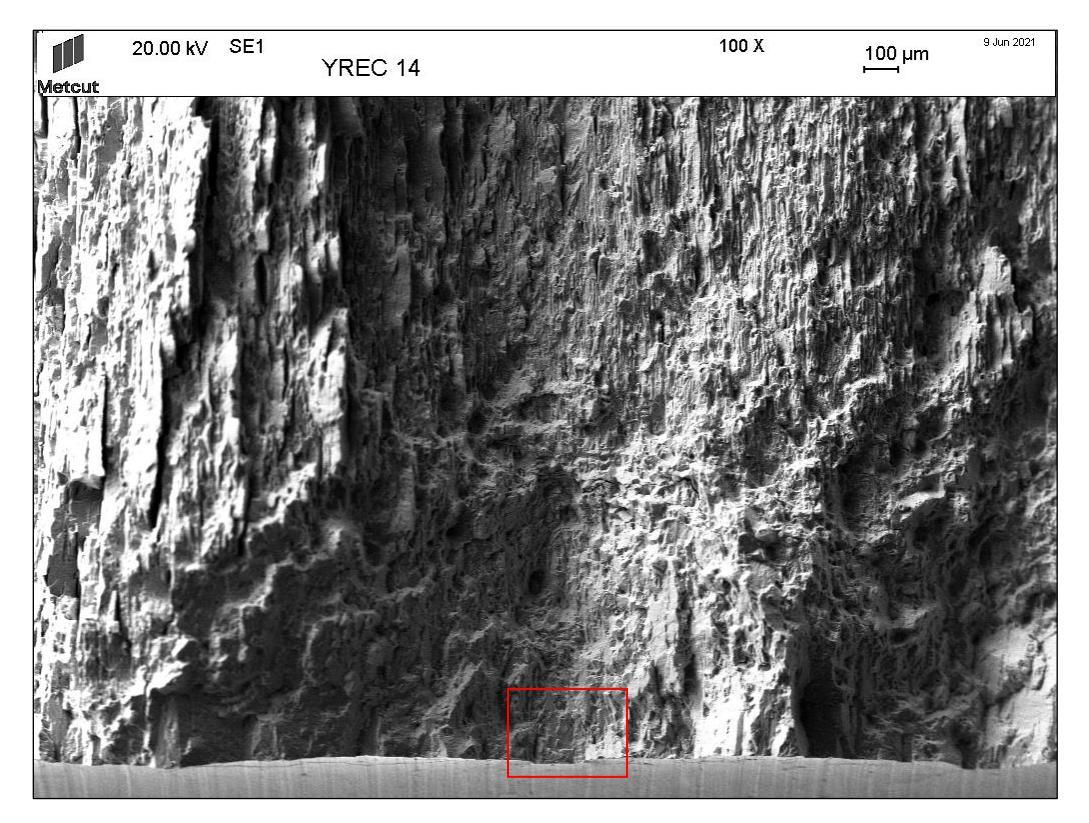
Figure 14. Fracture face of sample YREC 14, Site 2 is viewed at intermediate magnification, (SEI mode, 0° tilt). A red box identifies the initiation site.

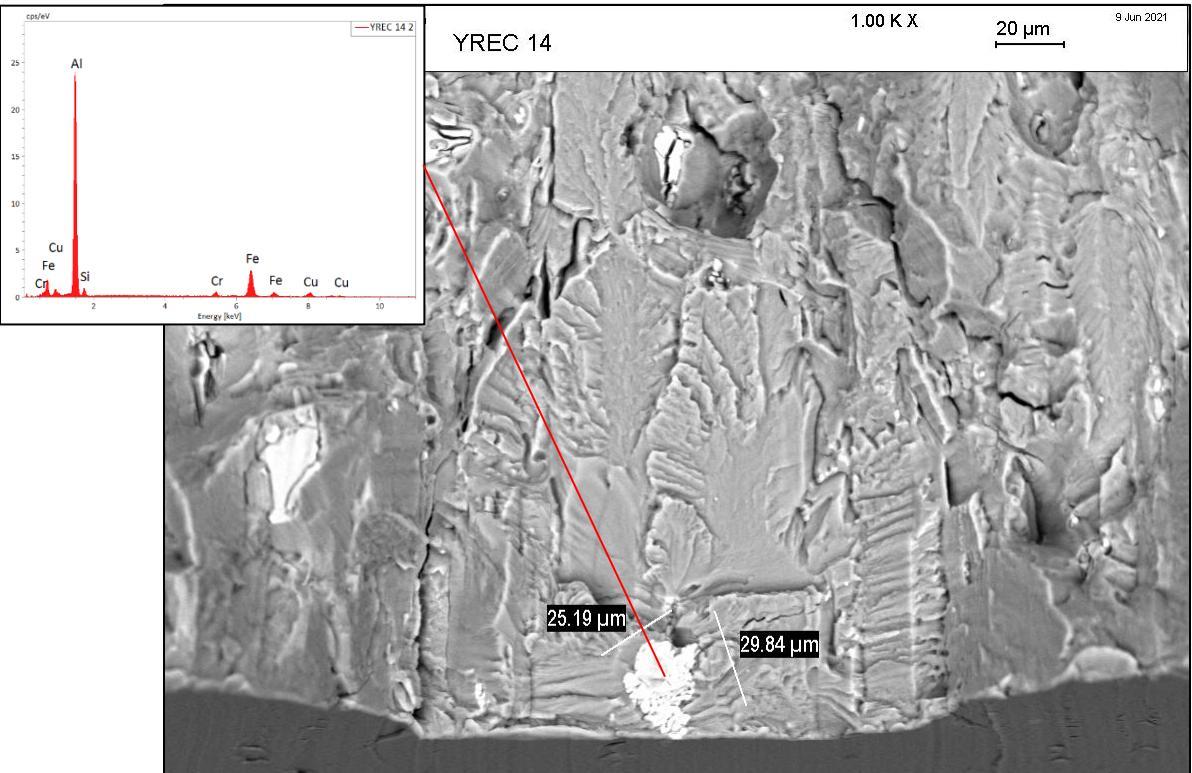
Figure 15. Initiation site for specimen YREC 14, Site 2 is seen at higher magnification, (BEI mode, 0° tilt). Inclusion at the surface measuring 12.6 µm x 36.1 µm was observed at the initiation site. Inclusion contains mostly Aluminum with concentrations of Iron, Copper, Silicon and Chromium.

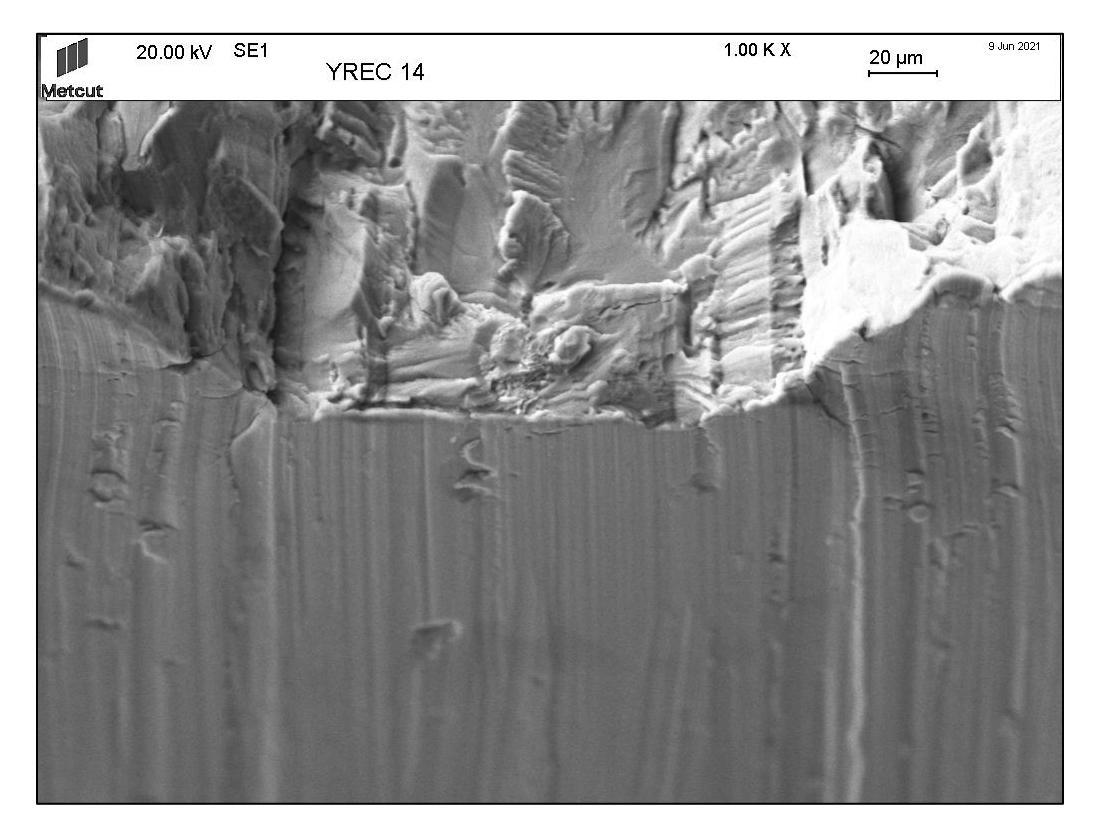
Figure 16. Initiation site for specimen YREC 14, Site 2 is seen at higher magnification, (SEI mode, 15° tilt).
