E-Drill Damage Rectification Process Validation

E-Drill Damage Rectification Process Validation					
Document No.:	61-222	Revision:	A	Date:	7/02/2018

Test Procedure Validation and Preliminary Results Executive Summary

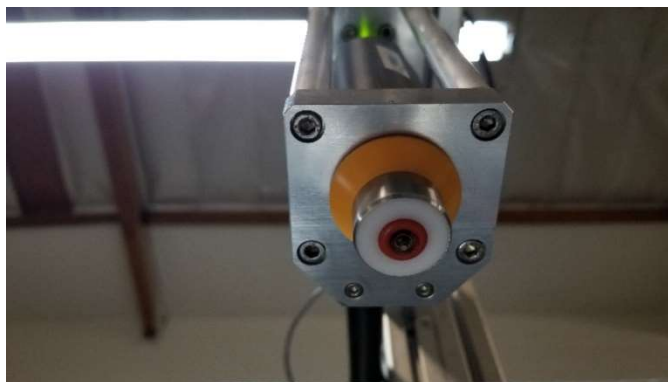
Figure 3: E-Drill Alignment Bushing.

Alignment of the E-Drill Fixture and Coupon Fixture was checked in several ways. First with a dial indicator, a coupon was compared to the coupon fixture bore and adjustments made. This was also verified by use of a Perfect Point EDM Bomb Sight. Second a precision ground sleeve is mounted to a Vacuum Flush Head Adaptor (VFHL), to ensure concentric alignment of the E-Drill and Coupon Fixture. Third an E-Drill mounting cage is affixed to the holding frame and aligned to hold a standard production Center Grounding E-Drill. The coupon fixture assembly is then concentrically aligned to the VFHL and E-Drill assembly.

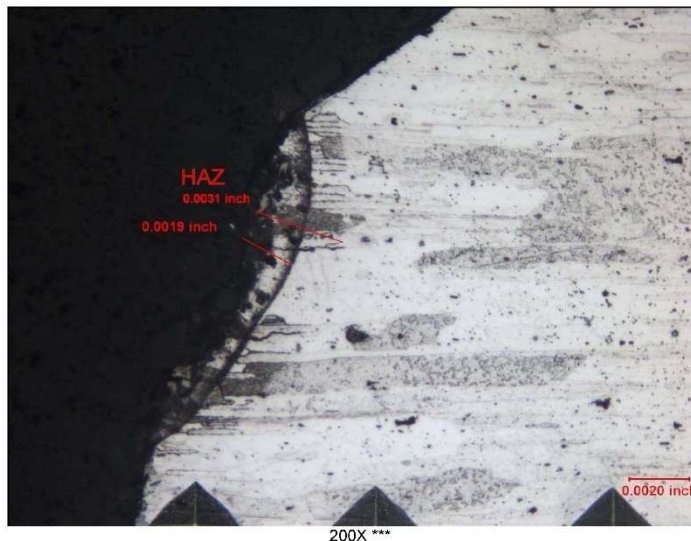
Microhardness Evaluation
S/N 14***

Requirement:	FOR INFO. ONLY	
Load in grams:	500g	
Magnification:	400X	
Sample / Location	Vickers	Rockwell HRB
0.002"	144	78
0.008"	158	83
0.016"	162	84
	Approximate conversion per ASTM E-140 (12b ^{E1})
