LABORATORY REPORT

PROJECT NO.: 6032-106782-2
REVISION NO.: 0
DATE: June 25, 2021
AUTHORIZATION: P1367-SBIR

PROJECT: Per customer's request, Metcut Research Inc. sectioned, mounted, polished, etched, and analyzed the supplied specimens, see Figure 1.

1. Metallographic evaluation of EDM cut surfaces.

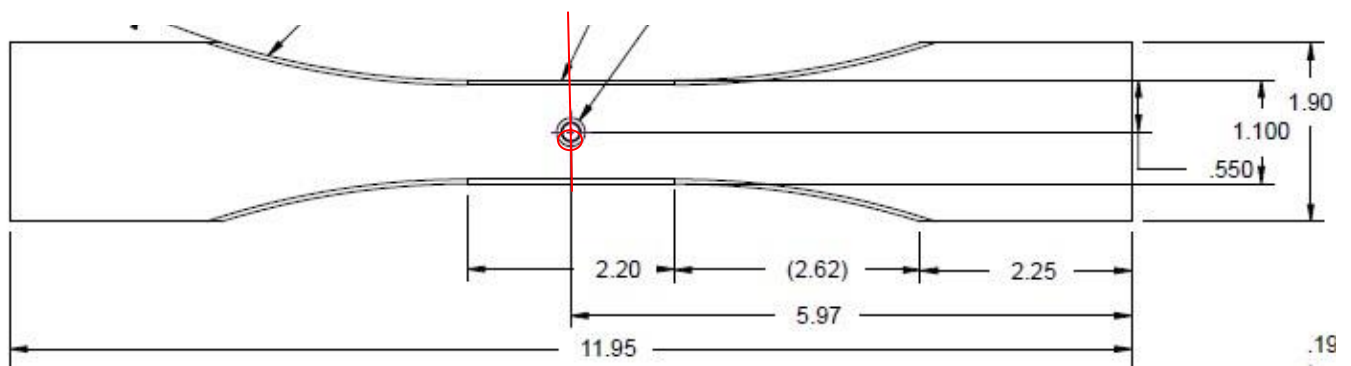
FIGURE 1. Drawing of EDM samples received for analysis. Red line shows sectioning location. Red circle shows area of interest shown in photomicrographs.

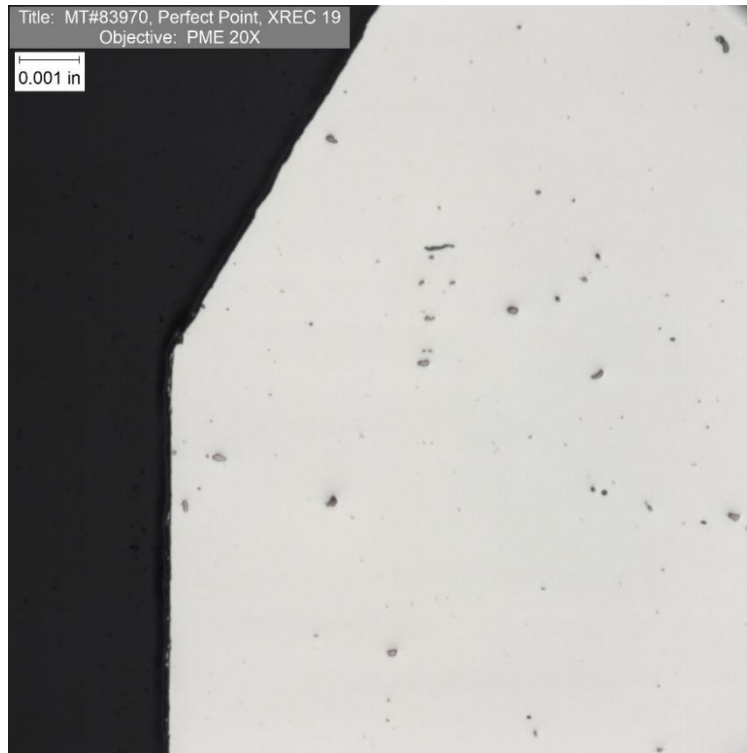
FIGURE 2. MRI Mount No.: 83970. Typical microstructure of the supplied sample XREC 19 is presented in the unetched condition showing the full EDM cut area. No cracking observed. 200X magnification.

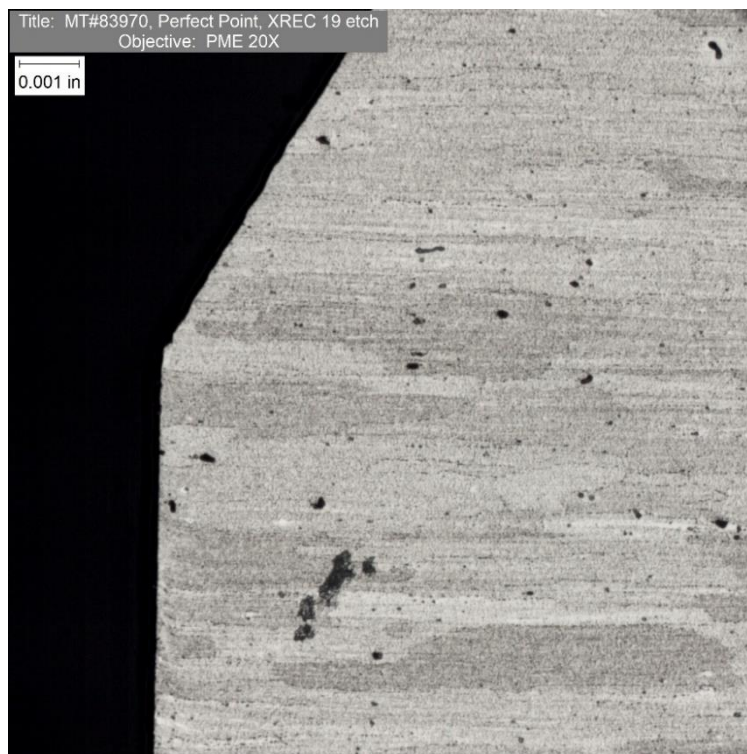
FIGURE 3. MRI Mount No.: 83970. Microstructure of the supplied sample XREC 19 is presented in the etched condition showing EDM cut. No recast layer was observed. 200X magnification, Keller's etch.

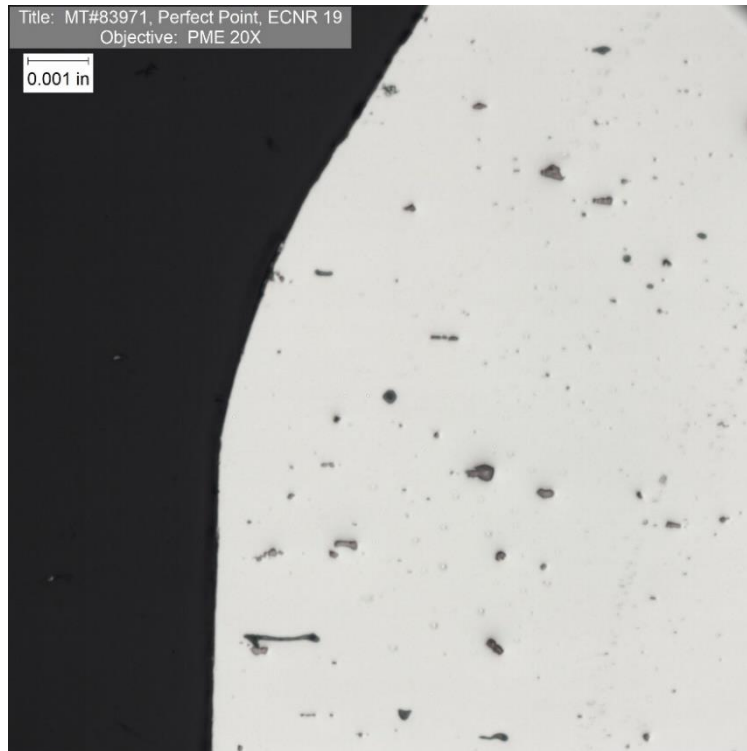
FIGURE 4. MRI Mount No.: 83971. Typical microstructure of the supplied sample ECNR 19 is presented in the unetched condition showing the full EDM cut area. No cracking observed. 200X magnification.

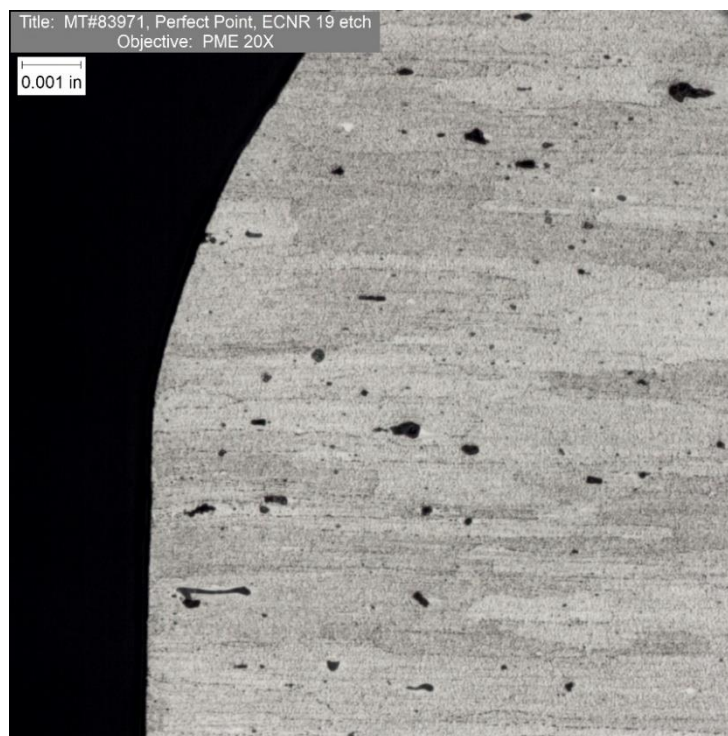
FIGURE 5. MRI Mount No.: 83971. Microstructure of the supplied sample ECNR 19 is presented in the etched condition showing EDM cut. No recast layer was observed. 200X magnification, Keller's etch.

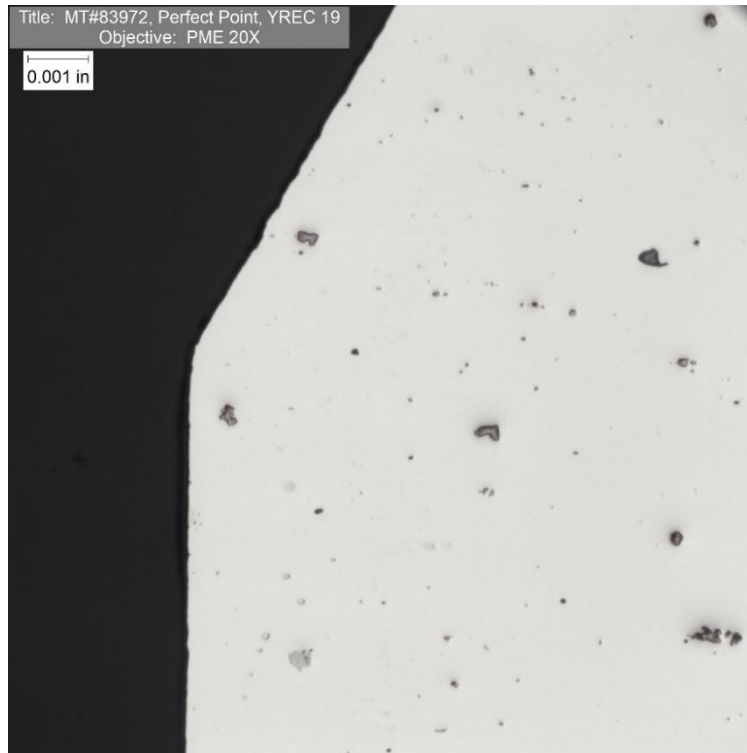
FIGURE 6. MRI Mount No.: 83972. Typical microstructure of the supplied sample YREC 19 is presented in the unetched condition showing the full EDM cut area. No cracking observed. 200X magnification.

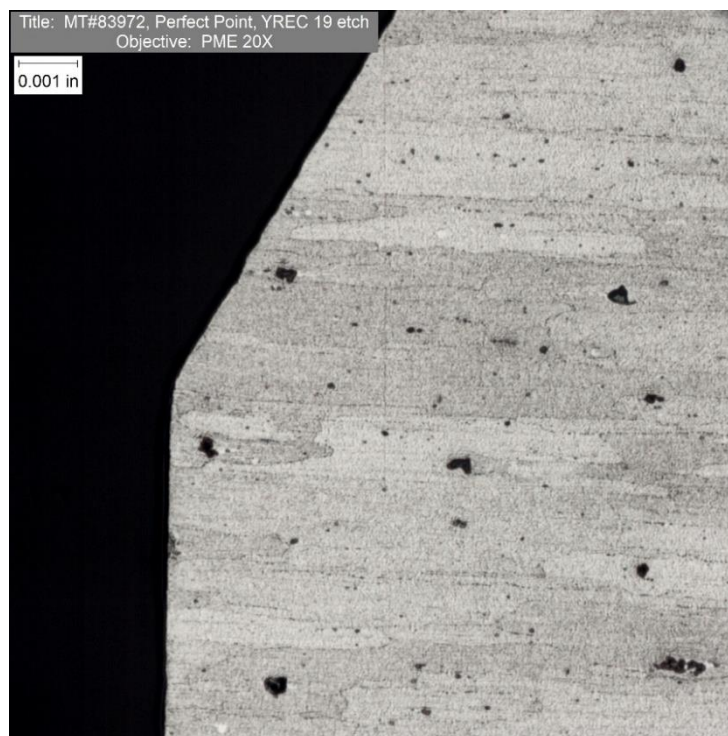
FIGURE 7. MRI Mount No.: 83972. Microstructure of the supplied sample YREC 19 is presented in the etched condition showing EDM cut. No recast layer was observed. 200X magnification, Keller's etch.
